Access Compliance Report Public Rights-of-Way (Curb Ramps)

Intersection ID: 13926 Main Street: PENCE_RD Cross Street: VIOLA_DR Location: SW

ADA ID: A296C559D0EB Ramp Type: Para Initial Pass/Fail: Fail Overall Compliance: No Severity Score: 13.75

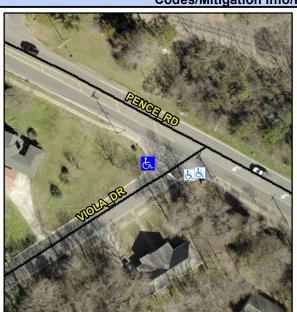
VEGETATION OVERGROWTH. NO
LT SW, LT RP < 5%

Field Measurements/Component Compliance						
Comp	liance Description	Data	Comp	liance Description	Data	
N/A	Ramp Length LT (in)	54.5	N/A	Ramp Length RT (in)	52.0	
Yes	Ramp Width LT (in)	61.0	Yes	Ramp Width RT (in)	61.0	
Yes	Ramp Slope LT (%)	2.0	No	Ramp Slope RT (%)	9.9	
No	Ramp XSlope LT (%)	3.4	No	Ramp XSlope RT (%)	2.1	
N/A	Landing Length (in)	N/A	N/A	DWS Provided?	N/A	
N/A	Landing Width (in)	N/A	N/A	DWS Contrast?	N/A	
N/A	Landing Slope (%)	N/A	N/A	DWS Length (in)	N/A	
N/A	Landing X Slope (%)	N/A	N/A	DWS Full Width?	N/A	
N/A	Landing Curb? (Y/N)	N/A	N/A	DWS Offset (in)	N/A	
N/A	Shared Landing?	N/A				
N/A	Gutter Ponding?	N/A	N/A	Gutter Slope (%)	N/A	
N/A	Gutter Lip Ht (in)	N/A	N/A	Gutter X Slope (%)	N/A	
N/A	Painted X Walk1?	No	N/A	Painted X Walk2?	N/A	
	X Walk 1 Direction	To E		X Walk 2 Direction	N/A	
N/A	X Walk 1 Width (in)	N/A	N/A	X Walk 2 Width (in)	N/A	
	X Walk 1 Slope (%)	3.6		X Walk 2 Slope (%)	N/A

X Walk 1 X Slope (%)	2.7		X Walk 2 X Slope (%)	N/A	
N/A	Ramp inside XWalk1?	N/A	N/A	Ramp inside XWalk2?	N/A	
	Road Slope (%)	N/A	N/A	Clear Space?	N/A	
	Road X Slope (%)	N/A	N/A	Clear Space to XWalk (in)	N/A	
N/A	Any Obstructions?	N/A	N/A	Storm Grate/Utility Hazard?	N/A	
	Obstruction Type			Storm Grate/Utility Type		
		N/A			N/A	
			Yes	Surface Condition? (G/P)	Good	
			N/A	Curb Slope (%)	18.7	
والمالة

Remove & Replace Entire Ramp.
