# Access Compliance Report

## Public Rights-of-Way

### (Curb Ramps)

Intersection ID: 50316	Main Street: ESMERALDA_DR	Cross Street: STATESVILLE_RD	Location: SW
ADA ID: A2979A917141	Ramp Type: Perp	Initial Pass/Fail: Fail	Overall Compliance: No
Severity Score: 22.5			
Codes/Mitigation Info/Possible Solution		Field Measurements/Component Compliance

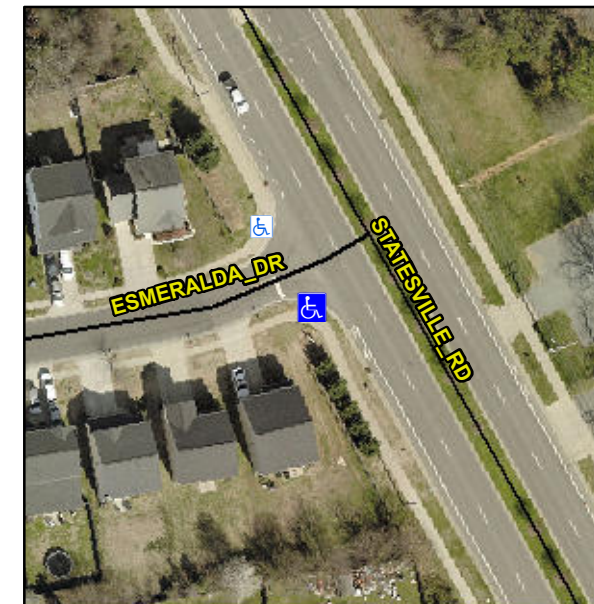
**Not Found, R304.5.1, R304.2.2, R304.5.3**

Compliance	Description	Data	Compliance	Description	Data
N/A	Ramp Length (in)	49.5	No	Ramp Slope (%)	9.0
No	Ramp Width (in)	47.0	No	Ramp XSlope (%)	2.9
N/A	Flare Type LT	N/A	N/A	Flare Type RT	N/A
N/A	Flare Slope LT (%)	N/A	N/A	Flare Slope RT (%)	N/A
N/A	Flare Traversable LT?	N/A	N/A	Flare Traversable RT?	N/A
N/A	Landing Length (in)	N/A	N/A	DWS Provided?	N/A
N/A	Landing Width (in)	N/A	N/A	DWS Contrast?	N/A
N/A	Landing Slope (%)	N/A	N/A	DWS Length (in)	N/A
N/A	Landing X Slope (%)	N/A	N/A	DWS Full Width?	N/A
N/A	Landing Curb? (Y/N)	N/A	N/A	DWS Offset (in)	N/A
N/A	Shared Landing?	N/A			
N/A	Gutter Ponding?	N/A	N/A	Gutter Slope (%)	N/A
N/A	Gutter Lip Ht (in)	N/A	N/A	Gutter X Slope (%)	N/A
N/A	Painted X Walk1?	No	N/A	Painted X Walk2?	N/A
	X Walk 1 Direction	To N		X Walk 2 Direction	N/A
N/A	X Walk 1 Width (in)	N/A	N/A	X Walk 2 Width (in)	N/A
	X Walk 1 Slope (%)	0.3		X Walk 2 Slope (%)	N/A
	X Walk 1 X Slope (%)	3.0		X Walk 2 X Slope (%)	N/A

N/A	Ramp inside XWalk1?	N/A	N/A	Ramp inside XWalk2?	N/A
	Road Slope (%)	N/A	N/A	Clear Space?	N/A
	Road X Slope (%)	N/A	N/A	Clear Space to XWalk (in)	N/A
N/A	Any Obstructions?	N/A	N/A	Storm Grate/Utility Hazard?	N/A
	Obstruction Type			Storm Grate/Utility Type	
		N/A			N/A
			Yes	Surface Condition? (G/P)	Good

**Remove & Replace Entire Ramp.**
