Access Compliance Report

Public Rights-of-Way

(Curb Ramps)

Intersection ID: 27006	Main Street: ORCHID_HILL_LN	Cross Street: RED_MAPLE_DR	Location: S
ADA ID: A2991732ABEC	Ramp Type: PerpDiag	Initial Pass/Fail: Fail	Overall Compliance: No
		Severity Score: 50

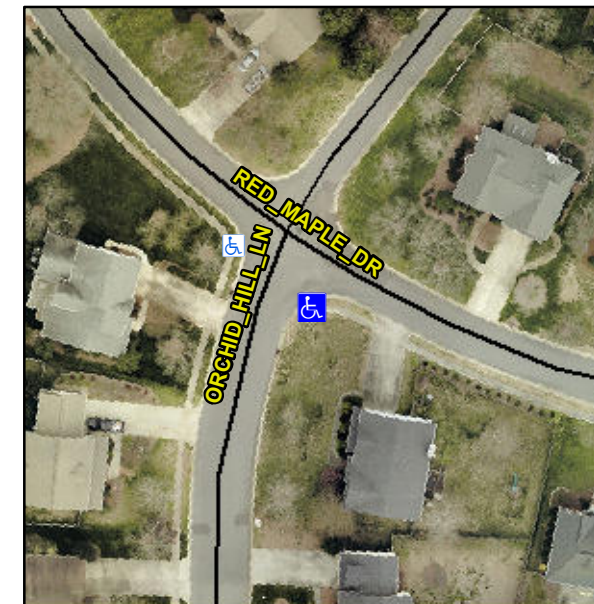
Compliance	Description	Data	Compliance	Description	Data
N/A	Ramp Length (in)	95.0	No	Ramp Slope (%)	17.6
Yes	Ramp Width (in)	48.0	No	Ramp XSlope (%)	14.6
N/A	Flare Type LT	N/A	N/A	Flare Type RT	N/A
N/A	Flare Slope LT (%)	N/A	N/A	Flare Slope RT (%)	N/A
N/A	Flare Traversable LT?	N/A	N/A	Flare Traversable RT?	N/A
N/A	Landing Length (in)	N/A	N/A	DWS Provided?	N/A
N/A	Landing Width (in)	N/A	N/A	DWS Contrast?	N/A
N/A	Landing Slope (%)	N/A	N/A	DWS Length (in)	N/A
N/A	Landing X Slope (%)	N/A	N/A	DWS Full Width?	N/A
N/A	Landing Curb? (Y/N)	N/A	N/A	DWS Offset (in)	N/A
N/A	Shared Landing?	N/A			
N/A	Gutter Ponding?	N/A	N/A	Gutter Slope (%)	N/A
N/A	Gutter Lip Ht (in)	N/A	N/A	Gutter X Slope (%)	N/A
N/A	Painted X Walk1?	No	N/A	Painted X Walk2?	No
	X Walk 1 Direction	To NE		X Walk 2 Direction	To NW
N/A	X Walk 1 Width (in)	N/A	N/A	X Walk 2 Width (in)	N/A
	X Walk 1 Slope (%)	0.5		X Walk 2 Slope (%)	8.7
	X Walk 1 X Slope (%)	13.1		X Walk 2 X Slope (%)	3.4

N/A	Ramp inside XWalk1?	N/A	N/A	Ramp inside XWalk2?	N/A
	Road Slope (%)	10.0	N/A	Clear Space?	N/A
	Road X Slope (%)	7.6	N/A	Clear Space to XWalk (in)	N/A
N/A	Any Obstructions?	N/A	N/A	Storm Grate/Utility Hazard?	N/A
	Obstruction Type			Storm Grate/Utility Type	
		N/A			N/A
			Yes	Surface Condition? (G/P)	Good

Remove & Replace Curb Ramp With Two New Directional Ramps or Equivalent.

R304.2.2, R304.5.3
