# Access Compliance Report

## Public Rights-of-Way

### (Curb Ramps)

| Intersection ID: 49803 | Main Street: ATKINS_RIDGE_DR | Cross Street: MATARESE_CT | Location: | E |

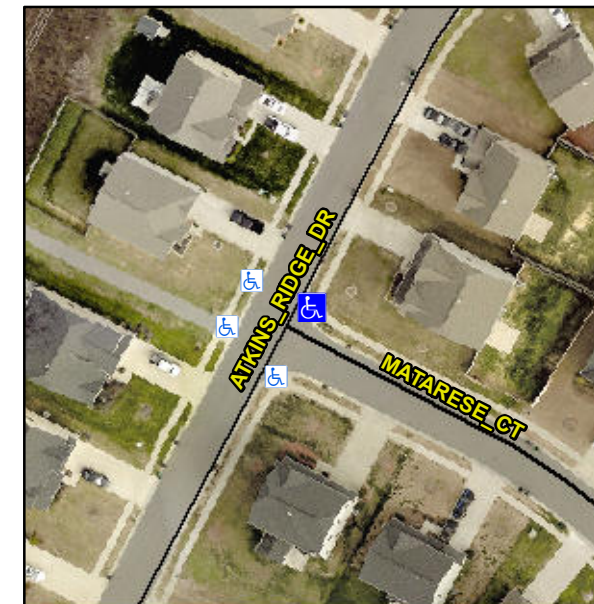
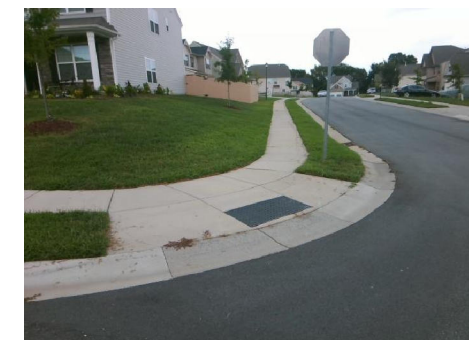
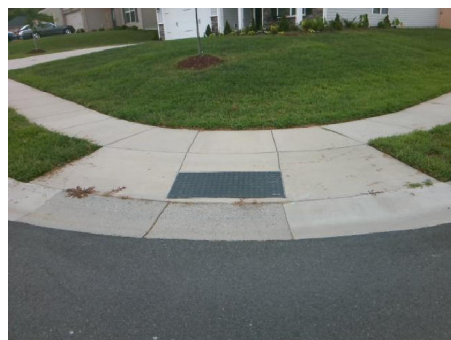
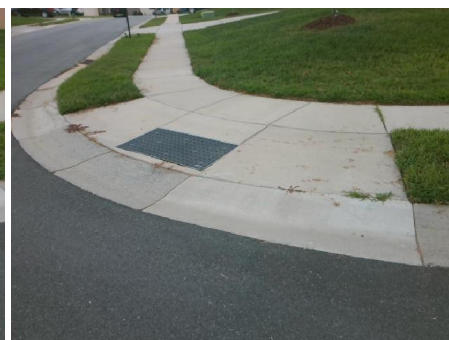
| ADA ID: A2A38836E1F7 | Ramp Type: PerpDiag | Initial Pass/Fail: Fail | Overall Compliance: No | Severity Score: 22.5 |

**Not Found, R304.5.1, R304.2.2, R304.5.3**

| Compliance | Description | Data | Compliance | Description | Data |
|---|---|---|---|---|---|
| N/A | Ramp Length (in) | 49.0 | No | Ramp Slope (%) | 10.8 |
| No | Ramp Width (in) | 45.0 | No | Ramp XSlope (%) | 2.2 |

**Remove & Replace Curb Ramp With Two New Directional Ramps or Equivalent.**
