# Access Compliance Report

## Public Rights-of-Way

### (Curb Ramps)

Intersection ID: 45167	Main Street: ARAGORN_LN	Cross Street: STRIDER_DR	Location: S
ADA ID: A2B0A54559D3	Ramp Type: BlendTrans1	Initial Pass/Fail: Fail	Overall Compliance: No
Severity Score: 8.75			
Codes/Mitigation Info/Possible Solution		Field Measurements/Component Compliance

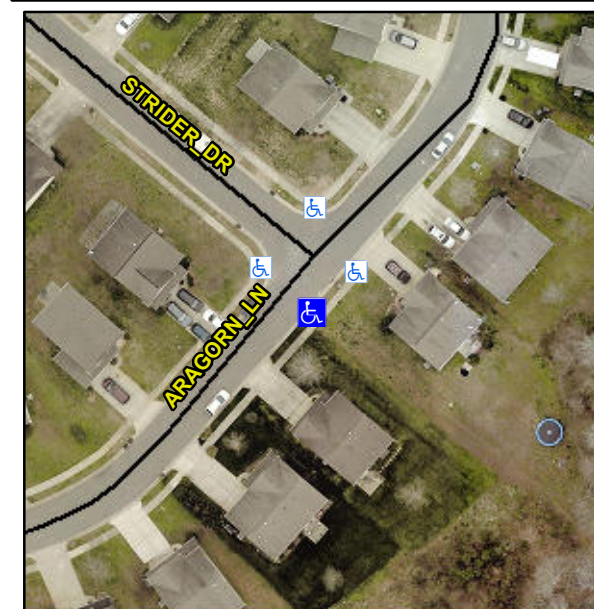
Compliance	Description	Data	Compliance	Description	Data
N/A	Ramp Length (in)	48.0	Yes	BlendTrans Slope (%)	3.5
No	Ramp Width (in)	41.5	Yes	BlendTrans XSlope (%)	0.1
N/A	Flare Type LT	N/A	N/A	Flare Type RT	N/A
N/A	Flare Slope LT (%)	N/A	N/A	Flare Slope RT (%)	N/A
N/A	Flare Traversable LT?	N/A	N/A	Flare Traversable RT?	N/A
N/A	Landing Length (in)	N/A	N/A	DWS Provided?	N/A
N/A	Landing Width (in)	N/A	N/A	DWS Contrast?	N/A
N/A	Landing Slope (%)	N/A	N/A	DWS Length (in)	N/A
N/A	Landing X Slope (%)	N/A	N/A	DWS Full Width?	N/A
N/A	Landing Curb? (Y/N)	N/A	N/A	DWS Offset (in)	N/A
N/A	Shared Landing?	N/A			
N/A	Gutter Ponding?	N/A	N/A	Gutter Slope (%)	N/A
N/A	Gutter Lip Ht (in)	N/A	N/A	Gutter X Slope (%)	N/A
N/A	Painted X Walk1?	No	N/A	Painted X Walk2?	N/A
	X Walk 1 Direction	To NW		X Walk 2 Direction	N/A
	X Walk 1 Width (in)	N/A		X Walk 2 Width (in)	N/A
	X Walk 1 Slope (%)	3.0		X Walk 2 Slope (%)	N/A
	X Walk 1 X Slope (%)	0.2		X Walk 2 X Slope (%)	N/A

N/A	Ramp inside XWalk1?	N/A	N/A	Ramp inside XWalk2?	N/A
	Road Slope (%)	0.2		Clear Space?	N/A
	Road X Slope (%)	3.0	N/A	Clear Space to XWalk (in)	N/A
N/A	Any Obstructions?	N/A	N/A	Storm Grate/Utility Hazard?	N/A
	Obstruction Type			Storm Grate/Utility Type	
		N/A			N/A
			Yes	Surface Condition? (G/P)	Good
			N/A	Curb Slope (%)	3.5

**Remove & Replace Curb Ramp With Two New Directional Ramps or Equivalent.**

**R304.5.1**

Total Cost: \$ 3200.00
