Access Compliance Report

Public Rights-of-Way

(Curb Ramps)

Intersection ID: 10022718	Main Street: CAROWINDS_BV	Cross Street: N/A	Location: SW
ADA ID: A2C1A89E1CDA	Ramp Type: PerpDiag	Initial Pass/Fail: Fail	Overall Compliance: No
Severity Score: 13.75			
Codes/Mitigation Info/Possible Solution		Field Measurements/Component Compliance

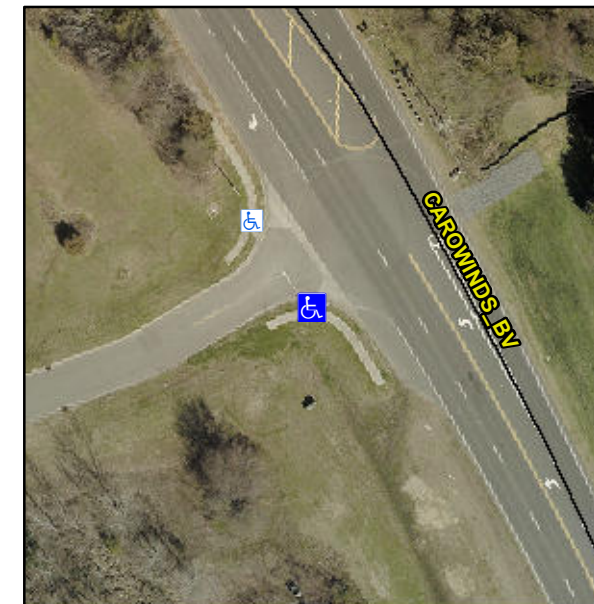
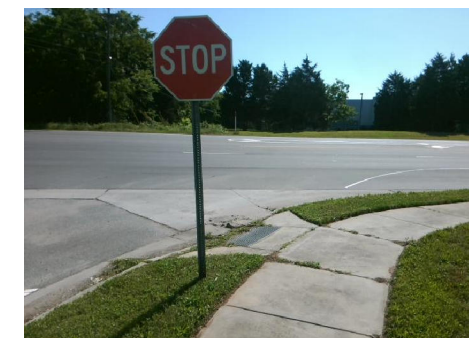
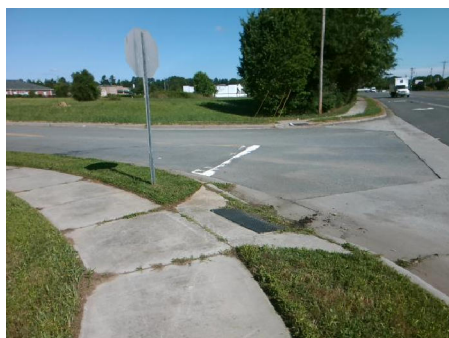
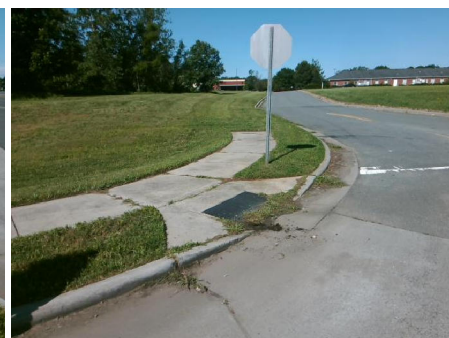
Not Found, R304.2.2, R304.5.3

Compliance	Description	Data	Compliance	Description	Data
N/A	Ramp Length (in)	48.0	No	Ramp Slope (%)	11.2
Yes	Ramp Width (in)	49.0	No	Ramp XSlope (%)	2.3
N/A	Flare Type LT	N/A	N/A	Flare Type RT	N/A
N/A	Flare Slope LT (%)	N/A	N/A	Flare Slope RT (%)	N/A
N/A	Flare Traversable LT?	N/A	N/A	Flare Traversable RT?	N/A
N/A	Landing Length (in)	N/A	N/A	DWS Provided?	N/A
N/A	Landing Width (in)	N/A	N/A	DWS Contrast?	N/A
N/A	Landing Slope (%)	N/A	N/A	DWS Length (in)	N/A
N/A	Landing X Slope (%)	N/A	N/A	DWS Full Width?	N/A
N/A	Landing Curb? (Y/N)	N/A	N/A	DWS Offset (in)	N/A
N/A	Shared Landing?	N/A			
N/A	Gutter Ponding?	N/A	N/A	Gutter Slope (%)	N/A
N/A	Gutter Lip Ht (in)	N/A	N/A	Gutter X Slope (%)	N/A
N/A	Painted X Walk1?	No	N/A	Painted X Walk2?	No
	X Walk 1 Direction	To E		X Walk 2 Direction	To N
N/A	X Walk 1 Width (in)	N/A	N/A	X Walk 2 Width (in)	N/A
	X Walk 1 Slope (%)	0.9		X Walk 2 Slope (%)	1.1
	X Walk 1 X Slope (%)	1.0		X Walk 2 X Slope (%)	0.8

N/A	Ramp inside XWalk1?	N/A	N/A	Ramp inside XWalk2?	N/A
	Road Slope (%)	3.7	N/A	Clear Space?	N/A
	Road X Slope (%)	2.2	N/A	Clear Space to XWalk (in)	N/A
N/A	Any Obstructions?	N/A	N/A	Storm Grate/Utility Hazard?	N/A
	Obstruction Type			Storm Grate/Utility Type	
		N/A			N/A
			Yes	Surface Condition? (G/P)	Good

Remove & Replace Curb Ramp With Two New Directional Ramps or Equivalent.
