# Access Compliance Report

## Public Rights-of-Way

### (Curb Ramps)

Intersection ID: 15071	Main Street: GREENBROOK_DR	Cross Street: TARRINGTON_AV	Location: SE
ADA ID: A2C7560CD689	Ramp Type: PerpDiag	Initial Pass/Fail: Fail	Overall Compliance: No
Severity Score: 12.5			
Codes/Mitigation Info/Possible Solution		Field Measurements/Component Compliance

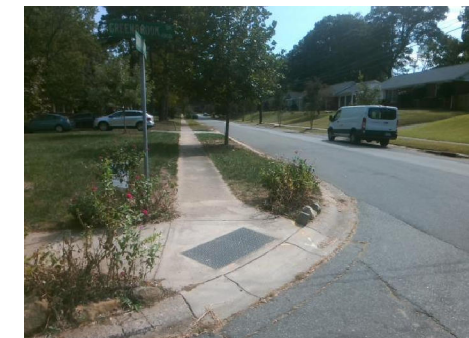
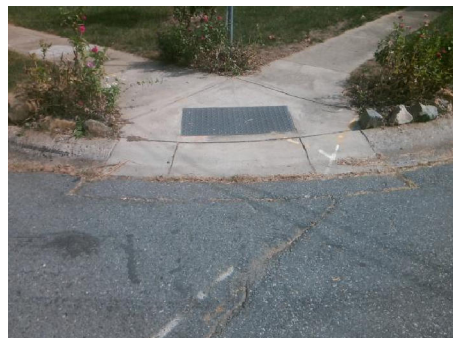
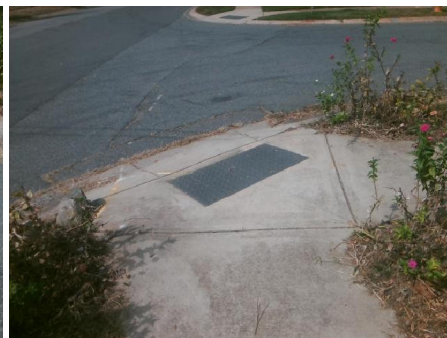
**Not Found, R304.2.2**

Compliance	Description	Data	Compliance	Description	Data
N/A	Ramp Length (in)	41.0	No	Ramp Slope (%)	9.1
Yes	Ramp Width (in)	48.0	Yes	Ramp XSlope (%)	1.7
N/A	Flare Type LT	N/A	N/A	Flare Type RT	N/A
N/A	Flare Slope LT (%)	N/A	N/A	Flare Slope RT (%)	N/A
N/A	Flare Traversable LT?	N/A	N/A	Flare Traversable RT?	N/A
N/A	Landing Length (in)	N/A	N/A	DWS Provided?	N/A
N/A	Landing Width (in)	N/A	N/A	DWS Contrast?	N/A
N/A	Landing Slope (%)	N/A	N/A	DWS Length (in)	N/A
N/A	Landing X Slope (%)	N/A	N/A	DWS Full Width?	N/A
N/A	Landing Curb? (Y/N)	N/A	N/A	DWS Offset (in)	N/A
N/A	Shared Landing?	N/A			
N/A	Gutter Ponding?	N/A	N/A	Gutter Slope (%)	N/A
N/A	Gutter Lip Ht (in)	N/A	N/A	Gutter X Slope (%)	N/A
N/A	Painted X Walk1?	No	N/A	Painted X Walk2?	No
	X Walk 1 Direction	To NW		X Walk 2 Direction	To SW
N/A	X Walk 1 Width (in)	N/A	N/A	X Walk 2 Width (in)	N/A
	X Walk 1 Slope (%)	2.1		X Walk 2 Slope (%)	3.9
	X Walk 1 X Slope (%)	1.7		X Walk 2 X Slope (%)	1.4

N/A	Ramp inside XWalk1?	N/A	N/A	Ramp inside XWalk2?	N/A
	Road Slope (%)	0.5	N/A	Clear Space?	N/A
	Road X Slope (%)	4.0	N/A	Clear Space to XWalk (in)	N/A
N/A	Any Obstructions?	N/A	N/A	Storm Grate/Utility Hazard?	N/A
	Obstruction Type			Storm Grate/Utility Type	
		N/A			N/A
		Yes		Surface Condition? (G/P)	Good

**Remove & Replace Curb Ramp With Two New Directional Ramps or Equivalent.**

Total Cost: \$ 3200.00
