Intersection ID: 8679	Main Street: HATERAS_AV	Cross Street: NEWCASTLE_ST	Location:	NW
ADA ID: A2C7962F60C3	Ramp Type: PerpDiag	Initial Pass/Fail: Fail	Overall Compliance: No	Severity Score: 25

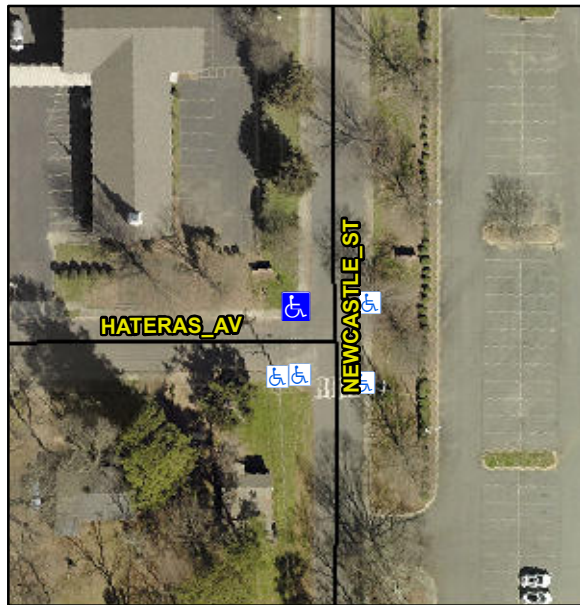
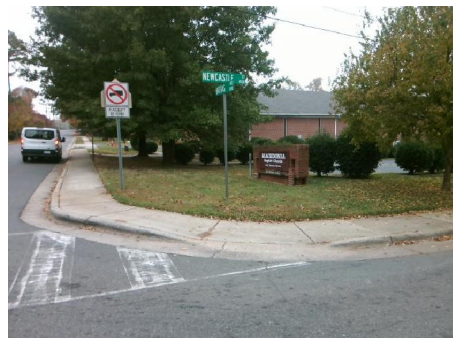
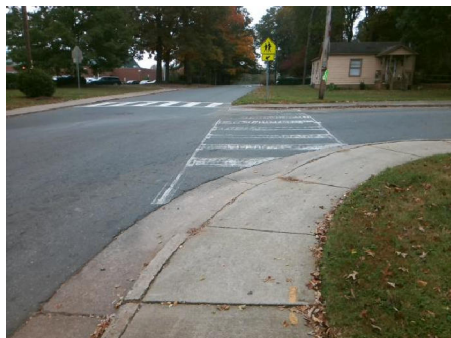
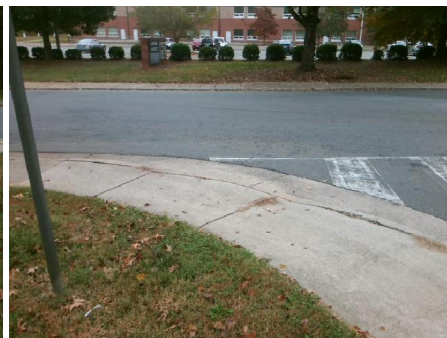
Not Found, R304.5.3

Compliance	Description	Data	Compliance	Description	Data
N/A	Ramp Length (in)	49.0	Yes	Ramp Slope (%)	5.8
Yes	Ramp Width (in)	57.0	No	Ramp XSlope (%)	7.0
N/A	Flare Type LT	N/A	N/A	Flare Type RT	N/A
N/A	Flare Slope LT (%)	N/A	N/A	Flare Slope RT (%)	N/A
N/A	Flare Traversable LT?	N/A	N/A	Flare Traversable RT?	N/A
N/A	Landing Length (in)	N/A	N/A	DWS Provided?	N/A
N/A	Landing Width (in)	N/A	N/A	DWS Contrast?	N/A
N/A	Landing Slope (%)	N/A	N/A	DWS Length (in)	N/A
N/A	Landing X Slope (%)	N/A	N/A	DWS Full Width?	N/A
N/A	Landing Curb? (Y/N)	N/A	N/A	DWS Offset (in)	N/A
N/A	Shared Landing?	N/A			
N/A	Gutter Ponding?	N/A	N/A	Gutter Slope (%)	N/A
N/A	Gutter Lip Ht (in)	0.5	N/A	Gutter X Slope (%)	N/A
N/A	Painted X Walk1?	Yes	N/A	Painted X Walk2?	No
	X Walk 1 Direction	To S		X Walk 2 Direction	To E
N/A	X Walk 1 Width (in)	111.0	N/A	X Walk 2 Width (in)	N/A
	X Walk 1 Slope (%)	4.2		X Walk 2 Slope (%)	3.4
	X Walk 1 X Slope (%)	2.6		X Walk 2 X Slope (%)	3.9

N/A	Ramp inside XWalk1?	Yes	N/A	Ramp inside XWalk2?	N/A
	Road Slope (%)	2.9	N/A	Clear Space?	N/A
	Road X Slope (%)	4.2	N/A	Clear Space to XWalk (in)	N/A
N/A	Any Obstructions?	N/A	N/A	Storm Grate/Utility Hazard?	N/A
	Obstruction Type			Storm Grate/Utility Type	
		N/A			N/A
			Yes	Surface Condition? (G/P)	Good

Remove & Replace Curb Ramp With Two New Directional Ramps or Equivalent.

Total Cost: \$ 3200.00
