## Access Compliance Report Public Rights-of-Way (Curb Ramps)

Intersection ID: 10031842Main Street:MINTWORTH\_AVCross Street: N/ANEADA ID: A2DEAAAE00CDRamp Type:PerpInitial Pass/Fail: FailOverall Compliance: NoSeverity Score:12.5

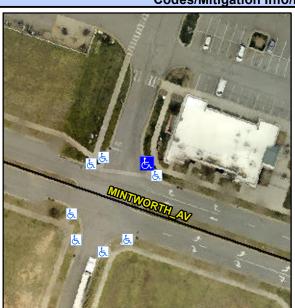
Comp	liance Description	Data		liance Description	Data
N/A	Ramp Length (in)	70.0	No	Ramp Slope (%)	8.5
Yes	Ramp Width (in)	48.0	Yes	Ramp XSlope (%)	1.0
N/A	Flare Type LT	N/A	N/A	Flare Type RT	N/A
N/A	Flare Slope LT (%)	N/A	N/A	Flare Slope RT (%)	N/A
N/A	Flare Traversable LT?	N/A	N/A	Flare Traversable RT?	N/A
N/A	Landing Length (in)	N/A	N/A	DWS Provided?	N/A
N/A	Landing Width (in)	N/A	N/A	DWS Contrast?	N/A
N/A	Landing Slope (%)	N/A	N/A	DWS Length (in)	N/A
N/A	Landing X Slope (%)	N/A	N/A	DWS Full Width?	N/A
N/A	Landing Curb? (Y/N)	N/A	N/A	DWS Offset (in)	N/A
N/A	Shared Landing?	N/A			
N/A	Gutter Ponding?	N/A	N/A	Gutter Slope (%)	N/A
N/A	Gutter Lip Ht (in)	N/A	N/A	Gutter X Slope (%)	N/A
N/A	Painted X Walk1?	No	N/A	Painted X Walk2?	N/A
	X Walk 1 Direction	To NW		X Walk 2 Direction	N/A
N/A	X Walk 1 Width (in)	N/A	N/A	X Walk 2 Width (in)	N/A
	X Walk 1 Slope (%)	0.7		X Walk 2 Slope (%)	N/A
	X Walk 1 X Slope (%)	2.0		X Walk 2 X Slope (%)	N/A

N/A	Ramp inside XWalk1?	N/A	N/A	Ramp inside XWalk2?	N/A
	Road Slope (%)	N/A	N/A	Clear Space?	N/A
	Road X Slope (%)	N/A	N/A	Clear Space to XWalk (in)	N/A
N/A	Any Obstructions?	N/A	N/A	Storm Grate/Utility Hazard?	N/A
	Obstruction Type			Storm Grate/Utility Type	
		N/A			N/A
			Yes	Surface Condition? (G/P)	Good

OSSIDIE SOIULIOII					
Possible Solutions:					
Remove & Replace Entire Ramp.					
•					
Surveyor Notes:					
N/A					
PROW/ADA:					
R304.2.2

Total Cost:	\$ 1850.00
