Access Compliance Report

Public Rights-of-Way

(Curb Ramps)

Intersection ID: 12278	Main Street: SEIGLE_AV	Cross Street: VAN_EVERY_ST	Location: E
ADA ID: A2E15319BFDF	Ramp Type: Perp	Initial Pass/Fail: Fail	Overall Compliance: No
Severity Score: 13.75			
Codes/Mitigation Info/Possible Solution		Field Measurements/Component Compliance

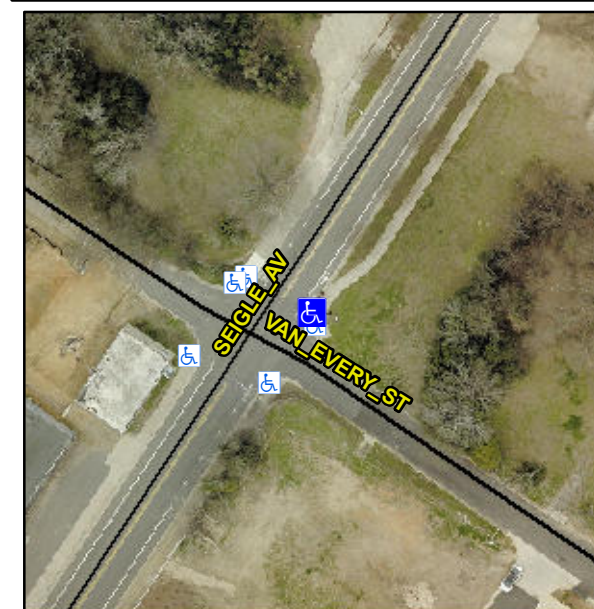
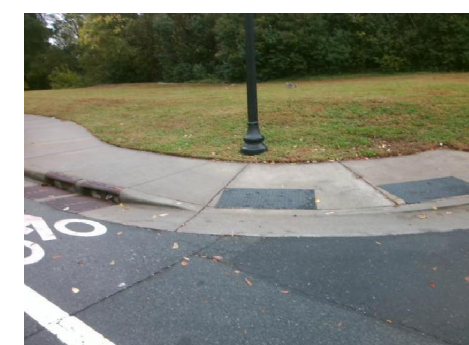
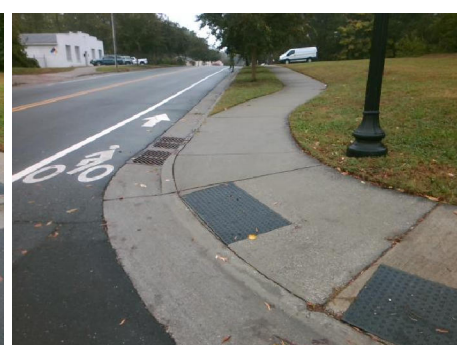
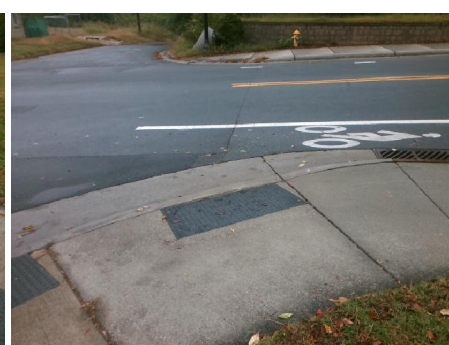
Not Found, R304.2.2

Compliance	Description	Data	Compliance	Description	Data
N/A	Ramp Length (in)	74.0	No	Ramp Slope (%)	9.9
Yes	Ramp Width (in)	59.0	Yes	Ramp XSlope (%)	2.4
N/A	Flare Type LT	N/A	N/A	Flare Type RT	N/A
N/A	Flare Slope LT (%)	N/A	N/A	Flare Slope RT (%)	N/A
N/A	Flare Traversable LT?	N/A	N/A	Flare Traversable RT?	N/A
N/A	Landing Length (in)	N/A	N/A	DWS Provided?	N/A
N/A	Landing Width (in)	N/A	N/A	DWS Contrast?	N/A
N/A	Landing Slope (%)	N/A	N/A	DWS Length (in)	N/A
N/A	Landing X Slope (%)	N/A	N/A	DWS Full Width?	N/A
N/A	Landing Curb? (Y/N)	N/A	N/A	DWS Offset (in)	N/A
N/A	Shared Landing?	N/A			
N/A	Gutter Ponding?	N/A	N/A	Gutter Slope (%)	N/A
N/A	Gutter Lip Ht (in)	N/A	N/A	Gutter X Slope (%)	N/A
N/A	Painted X Walk1?	No	N/A	Painted X Walk2?	N/A
	X Walk 1 Direction	To NW		X Walk 2 Direction	N/A
N/A	X Walk 1 Width (in)	N/A	N/A	X Walk 2 Width (in)	N/A
	X Walk 1 Slope (%)	1.5		X Walk 2 Slope (%)	N/A
	X Walk 1 X Slope (%)	5.0		X Walk 2 X Slope (%)	N/A

N/A	Ramp inside XWalk1?	N/A	N/A	Ramp inside XWalk2?	N/A
	Road Slope (%)	N/A	N/A	Clear Space?	N/A
	Road X Slope (%)	N/A	N/A	Clear Space to XWalk (in)	N/A
N/A	Any Obstructions?	N/A	N/A	Storm Grate/Utility Hazard?	N/A
	Obstruction Type			Storm Grate/Utility Type	
		N/A			N/A
		Yes		Surface Condition? (G/P)	Good

Remove & Replace Entire Ramp.

Total Cost: \$ 1850.00
