# Access Compliance Report

## Public Rights-of-Way

### (Curb Ramps)

Intersection ID: 7466	Main Street: S_I-85_EXIT_39_RA	Cross Street: STATESVILLE_RD	Location: SE
ADA ID: A2EBDD1CE77A	Ramp Type: Perp	Initial Pass/Fail: Fail	Overall Compliance: No
Severity Score: 33.75			
Codes/Mitigation Info/Possible Solution		Field Measurements/Component Compliance

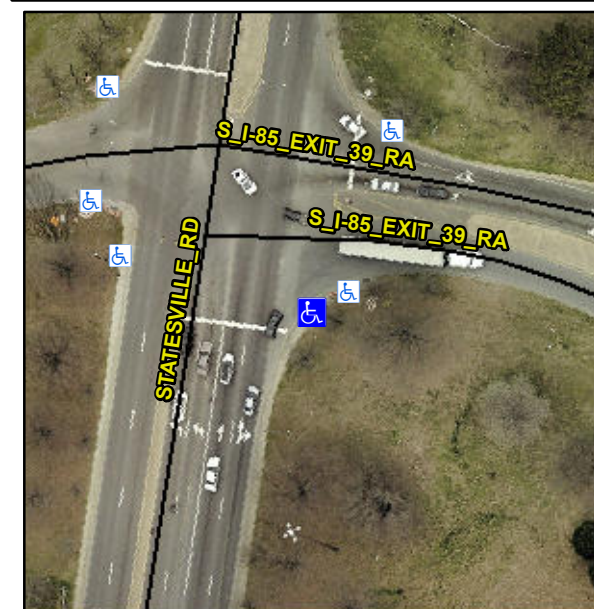
**Not Found, R304.5.1, R304.2.2, R304.5.3**

Compliance	Description	Data	Compliance	Description	Data
N/A	Ramp Length (in)	60.0	No	Ramp Slope (%)	8.8
No	Ramp Width (in)	36.0	No	Ramp XSlope (%)	6.4
N/A	Flare Type LT	N/A	N/A	Flare Type RT	N/A
N/A	Flare Slope LT (%)	N/A	N/A	Flare Slope RT (%)	N/A
N/A	Flare Traversable LT?	N/A	N/A	Flare Traversable RT?	N/A
N/A	Landing Length (in)	N/A	N/A	DWS Provided?	N/A
N/A	Landing Width (in)	N/A	N/A	DWS Contrast?	N/A
N/A	Landing Slope (%)	N/A	N/A	DWS Length (in)	N/A
N/A	Landing X Slope (%)	N/A	N/A	DWS Full Width?	N/A
N/A	Landing Curb? (Y/N)	N/A	N/A	DWS Offset (in)	N/A
N/A	Shared Landing?	N/A			
N/A	Gutter Ponding?	N/A	N/A	Gutter Slope (%)	N/A
N/A	Gutter Lip Ht (in)	0.5	N/A	Gutter X Slope (%)	N/A
N/A	Painted X Walk1?	No	N/A	Painted X Walk2?	N/A
	X Walk 1 Direction	To W		X Walk 2 Direction	N/A
N/A	X Walk 1 Width (in)	N/A	N/A	X Walk 2 Width (in)	N/A
	X Walk 1 Slope (%)	2.0		X Walk 2 Slope (%)	N/A
	X Walk 1 X Slope (%)	0.9		X Walk 2 X Slope (%)	N/A

**Remove & Replace Entire Ramp.**

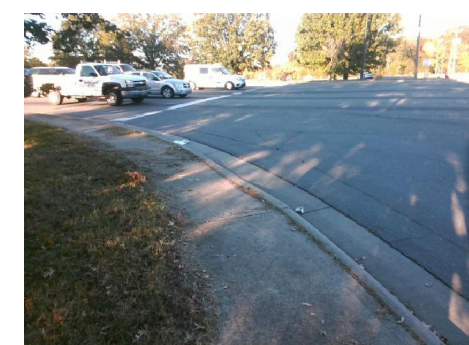
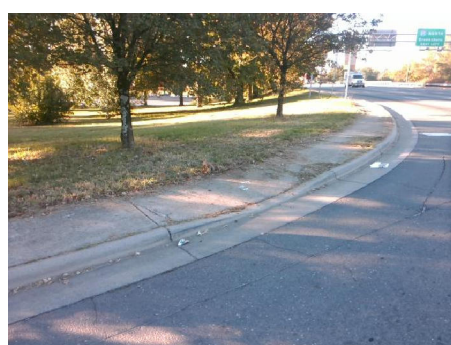
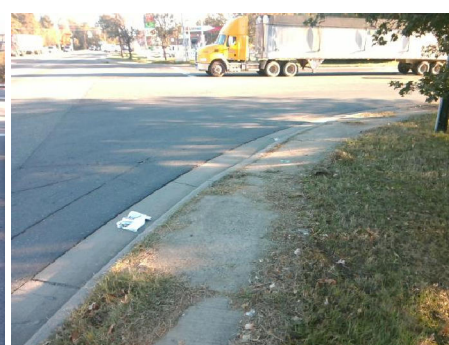
N/A	Ramp inside XWalk1?	N/A	N/A	Ramp inside XWalk2?	N/A
	Road Slope (%)	N/A	N/A	Clear Space?	N/A
	Road X Slope (%)	N/A	N/A	Clear Space to XWalk (in)	N/A
N/A	Any Obstructions?	N/A	N/A	Storm Grate/Utility Hazard?	N/A
	Obstruction Type			Storm Grate/Utility Type	
		N/A			N/A
			Yes	Surface Condition? (G/P)	Good
