# Access Compliance Report

## Public Rights-of-Way

### (Curb Ramps)

Intersection ID: 48944	Main Street: LILLYSHIRE_PL	Cross Street: CALDWELL_RIDGE_PY	Location: SE
ADA ID: A2FD225663AB	Ramp Type: Perp	Initial Pass/Fail: Fail	Overall Compliance: No
Codes/Mitigation Info/Possible Solution		Field Measurements/Component Compliance	
Severity Score: 21.25

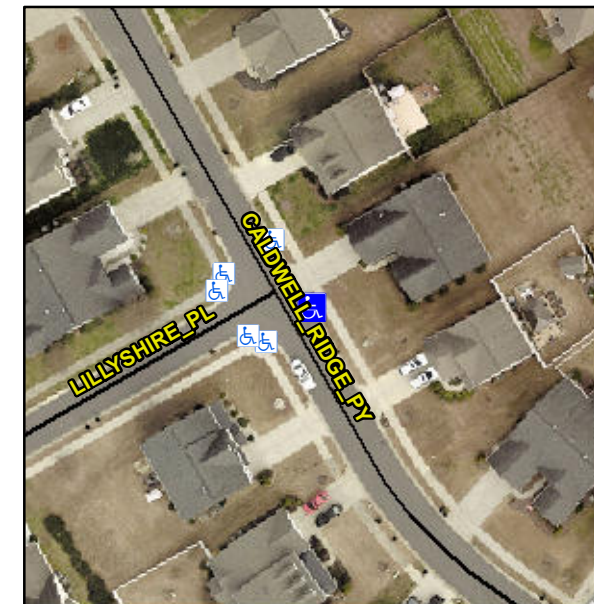
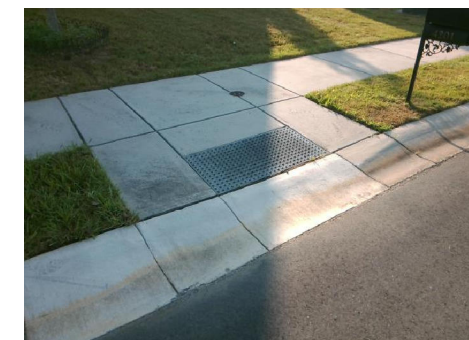
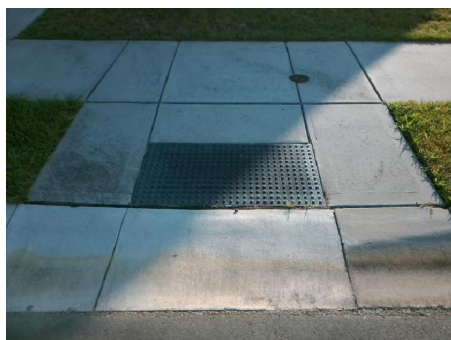
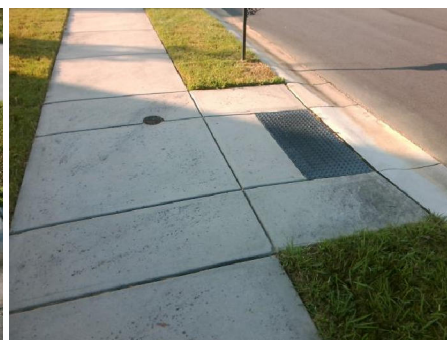
**Not Found, R304.5.1, R304.2.2**

Compliance	Description	Data	Compliance	Description	Data
N/A	Ramp Length (in)	46.5	No	Ramp Slope (%)	8.5
No	Ramp Width (in)	47.0	Yes	Ramp XSlope (%)	1.5
N/A	Flare Type LT	N/A	N/A	Flare Type RT	N/A
N/A	Flare Slope LT (%)	N/A	N/A	Flare Slope RT (%)	N/A
N/A	Flare Traversable LT?	N/A	N/A	Flare Traversable RT?	N/A
N/A	Landing Length (in)	N/A	N/A	DWS Provided?	N/A
N/A	Landing Width (in)	N/A	N/A	DWS Contrast?	N/A
N/A	Landing Slope (%)	N/A	N/A	DWS Length (in)	N/A
N/A	Landing X Slope (%)	N/A	N/A	DWS Full Width?	N/A
N/A	Landing Curb? (Y/N)	N/A	N/A	DWS Offset (in)	N/A
N/A	Shared Landing?	N/A			
N/A	Gutter Ponding?	N/A	N/A	Gutter Slope (%)	N/A
N/A	Gutter Lip Ht (in)	N/A	N/A	Gutter X Slope (%)	N/A
N/A	Painted X Walk1?	No	N/A	Painted X Walk2?	N/A
	X Walk 1 Direction	To SW		X Walk 2 Direction	N/A
N/A	X Walk 1 Width (in)	N/A	N/A	X Walk 2 Width (in)	N/A
	X Walk 1 Slope (%)	2.3		X Walk 2 Slope (%)	N/A
	X Walk 1 X Slope (%)	1.7		X Walk 2 X Slope (%)	N/A

N/A	Ramp inside XWalk1?	N/A	N/A	Ramp inside XWalk2?	N/A
	Road Slope (%)	N/A	N/A	Clear Space?	N/A
	Road X Slope (%)	N/A	N/A	Clear Space to XWalk (in)	N/A
N/A	Any Obstructions?	N/A	N/A	Storm Grate/Utility Hazard?	N/A
	Obstruction Type			Storm Grate/Utility Type	
		N/A			N/A
			Yes	Surface Condition? (G/P)	Good

**Remove & Replace Entire Ramp.**
