## Access Compliance Report Public Rights-of-Way (Curb Ramps)

Intersection ID: 3841	Main Sti	reat: CHIMNEY SPRIN		Cross Stree		GROVE DR		Location:	NW
	Main Street: CHIMNEY_SPRINGS_PL			Cross Street: POPLAR_GROVE_DR					
ADA ID: A2FE2A81C515 Ramp Type: Perp				Initial Pass/Fail: Fail Overall Compliance: No				o Severity Score:	21.25
Codes/Mitigation Info/Possible Solution				Field Measurements/Component Compliance					
		Possible Solutions:		Compliance Description Data			Comp	Compliance Description Dat	
A HANK AND	R	Remove & Replace	Entire Ramp.	N/A	Ramp Lengt	h (in) 50.0	Yes	Ramp Slope (%)	5.8

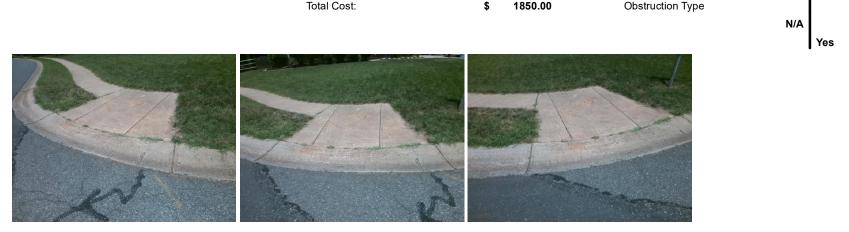
•	No	Ramp Width	(in) <b>47.0</b>	No	Ramp XSlope (%)	6.8
A DE TO	SA LIN			N/A	Flare Type L	T N/A	N/A	Flare Type RT	N/A
A CONTRACTOR OF				N/A	Flare Slope	LT (%) N/A	N/A	Flare Slope RT (%)	N/A
the Maria F				N/A	Flare Traver	sable LT? N/A	N/A	Flare Traversable RT?	N/A
				N/A	Landing Len	igth (in) N/A	N/A	DWS Provided?	N/A
E CAR	We we t	Surveyor Notes:		N/A	Landing Wid	lth (in) N/A	N/A	DWS Contrast?	N/A
Rob		N/A		N/A	Landing Slo	pe (%) N/A	N/A	DWS Length (in)	N/A
COL	RGROVEDR			N/A	Landing X S	lope (%) N/A	N/A	DWS Full Width?	N/A
in the k	0-00-0			N/A	Landing Cur	b? (Y/N) N/A	N/A	DWS Offset (in)	N/A
				N/A	Shared Land	ding? N/A			
	NO. THE NO.	PROW/ADA:		N/A	Gutter Pond	ling? N/A	N/A	Gutter Slope (%)	N/A
	T PI	Not Found, R304.5.	1, R304.5.3	N/A	Gutter Lip H	t (in) N/A	N/A	Gutter X Slope (%)	N/A
	A AND AND	,	,	N/A	Painted X W	/alk1? No	N/A	Painted X Walk2?	N/A
A CONTRACTOR	Y' CHI LA	9			X Walk 1 Dir	rection To E		X Walk 2 Direction	N/A
