Access Compliance Report

Public Rights-of-Way

(Curb Ramps)

Intersection ID: 30419	Main Street: FENWAY_DR	Cross Street: ELM_BEND_DR	Location: SW
ADA ID: A3040DFDFA33	Ramp Type: PerpDiag	Initial Pass/Fail: Fail	Overall Compliance: No
Severity Score: 21.25			
Codes/Mitigation Info/Possible Solution		Field Measurements/Component Compliance

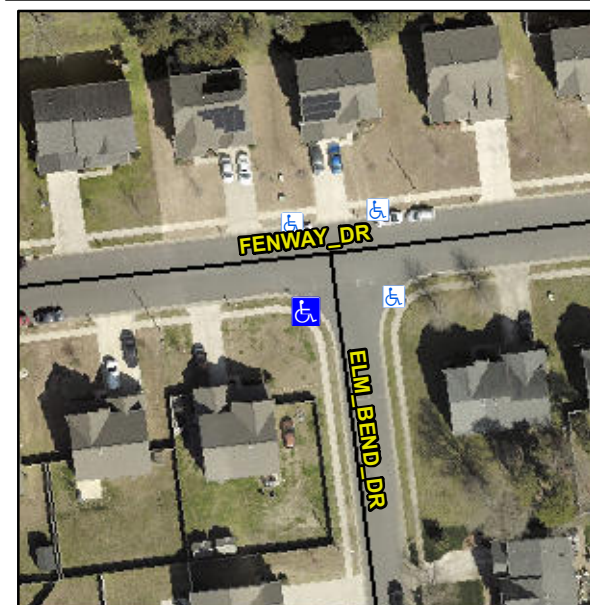
Not Found, R304.5.1, R304.2.2

Compliance	Description	Data	Compliance	Description	Data
N/A	Ramp Length (in)	48.0	No	Ramp Slope (%)	9.2
No	Ramp Width (in)	47.0	Yes	Ramp XSlope (%)	0.7
N/A	Flare Type LT	N/A	N/A	Flare Type RT	N/A
N/A	Flare Slope LT (%)	N/A	N/A	Flare Slope RT (%)	N/A
N/A	Flare Traversable LT?	N/A	N/A	Flare Traversable RT?	N/A
N/A	Landing Length (in)	N/A	N/A	DWS Provided?	N/A
N/A	Landing Width (in)	N/A	N/A	DWS Contrast?	N/A
N/A	Landing Slope (%)	N/A	N/A	DWS Length (in)	N/A
N/A	Landing X Slope (%)	N/A	N/A	DWS Full Width?	N/A
N/A	Landing Curb? (Y/N)	N/A	N/A	DWS Offset (in)	N/A
N/A	Shared Landing?	N/A			
N/A	Gutter Ponding?	N/A	N/A	Gutter Slope (%)	N/A
N/A	Gutter Lip Ht (in)	N/A	N/A	Gutter X Slope (%)	N/A
N/A	Painted X Walk1?	No	N/A	Painted X Walk2?	No
	X Walk 1 Direction	To E		X Walk 2 Direction	To N
N/A	X Walk 1 Width (in)	N/A	N/A	X Walk 2 Width (in)	N/A
	X Walk 1 Slope (%)	1.9		X Walk 2 Slope (%)	1.2
	X Walk 1 X Slope (%)	0.5		X Walk 2 X Slope (%)	0.3

N/A	Ramp inside XWalk1?	N/A	N/A	Ramp inside XWalk2?	N/A
	Road Slope (%)	0.5	N/A	Clear Space?	N/A
	Road X Slope (%)	3.5	N/A	Clear Space to XWalk (in)	N/A
N/A	Any Obstructions?	N/A	N/A	Storm Grate/Utility Hazard?	N/A
	Obstruction Type			Storm Grate/Utility Type	
		N/A			N/A
			Yes	Surface Condition? (G/P)	Good

Possible Solutions:

Remove & Replace Curb Ramp With Two New Directional Ramps or Equivalent.
