Access Compliance Report

Public Rights-of-Way

(Curb Ramps)

Intersection ID: 10022634	Main Street: CARMEL_RD	Cross Street: N/A	Location: SE
ADA ID: A320CE7C4399	Ramp Type: PerpDiag	Initial Pass/Fail: Fail	Overall Compliance: No
Severity Score: 21.25			
Codes/Mitigation Info/Possible Solution		Field Measurements/Component Compliance

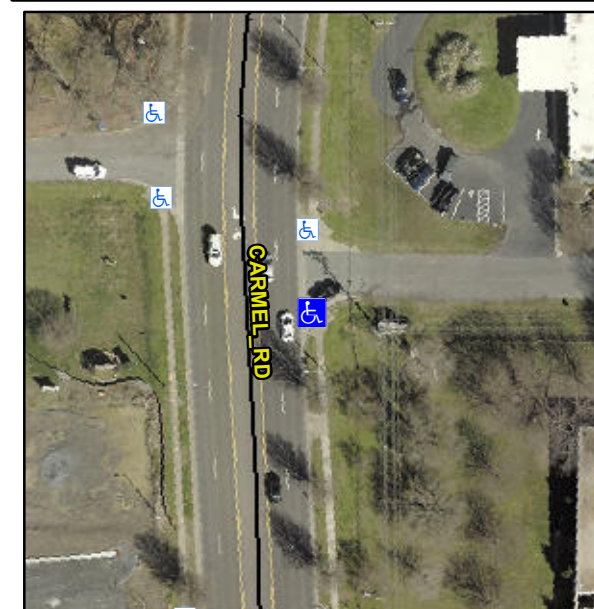
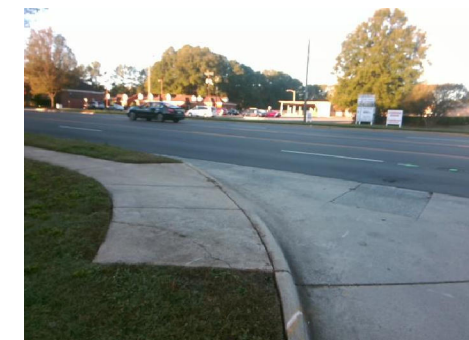
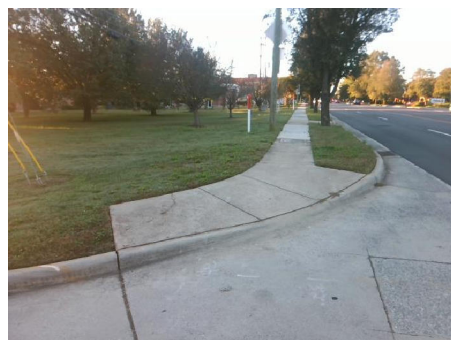
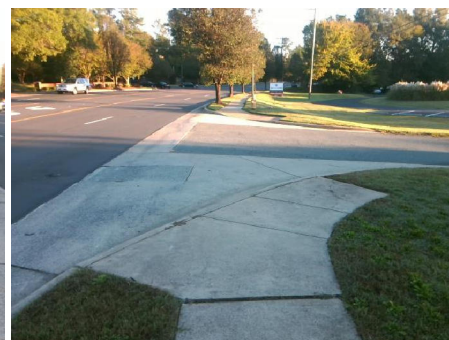
Compliance	Description	Data	Compliance	Description	Data
N/A	Ramp Length (in)	65.0	Yes	Ramp Slope (%)	7.4
No	Ramp Width (in)	41.5	No	Ramp XSlope (%)	5.6
N/A	Flare Type LT	N/A	N/A	Flare Type RT	N/A
N/A	Flare Slope LT (%)	N/A	N/A	Flare Slope RT (%)	N/A
N/A	Flare Traversable LT?	N/A	N/A	Flare Traversable RT?	N/A
N/A	Landing Length (in)	N/A	N/A	DWS Provided?	N/A
N/A	Landing Width (in)	N/A	N/A	DWS Contrast?	N/A
N/A	Landing Slope (%)	N/A	N/A	DWS Length (in)	N/A
N/A	Landing X Slope (%)	N/A	N/A	DWS Full Width?	N/A
N/A	Landing Curb? (Y/N)	N/A	N/A	DWS Offset (in)	N/A
N/A	Shared Landing?	N/A			
N/A	Gutter Ponding?	N/A	N/A	Gutter Slope (%)	N/A
N/A	Gutter Lip Ht (in)	N/A	N/A	Gutter X Slope (%)	N/A
N/A	Painted X Walk1?	No	N/A	Painted X Walk2?	No
	X Walk 1 Direction	To NE		X Walk 2 Direction	To NW
N/A	X Walk 1 Width (in)	N/A	N/A	X Walk 2 Width (in)	N/A
	X Walk 1 Slope (%)	1.6		X Walk 2 Slope (%)	3.9
	X Walk 1 X Slope (%)	6.0		X Walk 2 X Slope (%)	0.7

N/A	Ramp inside XWalk1?	N/A	N/A	Ramp inside XWalk2?	N/A
	Road Slope (%)	3.9	N/A	Clear Space?	N/A
	Road X Slope (%)	3.7	N/A	Clear Space to XWalk (in)	N/A
N/A	Any Obstructions?	N/A	N/A	Storm Grate/Utility Hazard?	N/A
	Obstruction Type			Storm Grate/Utility Type	
		N/A			N/A
		Yes		Surface Condition? (G/P)	Good

Remove & Replace Curb Ramp With Two New Directional Ramps or Equivalent.

R304.5.1, R304.5.3
