Access Compliance Report

Public Rights-of-Way

(Curb Ramps)

| Intersection ID: 30121 | Main Street: CLOONEY_LN | Cross Street: VERNON_WOOD_LN | Location: NW |

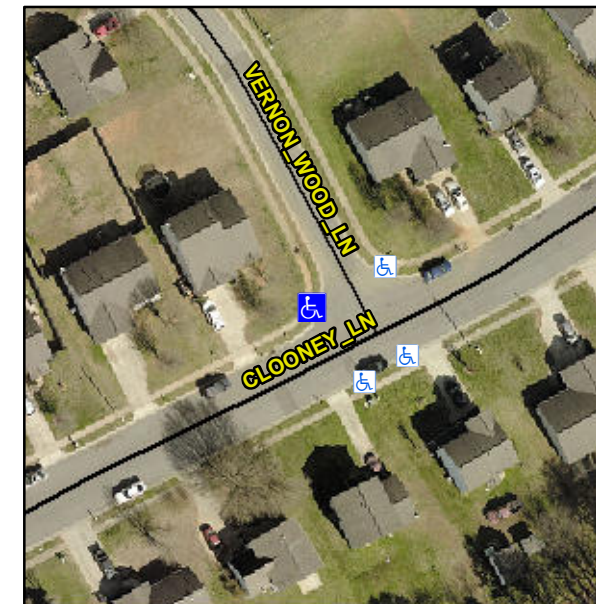
Not Found, R304.5.1, R304.2.2, R304.5.3

| Compliance | Description | Data | Compliance | Description | Data |
|---|---|---|---|---|---|
| N/A | Ramp Length (in) | 48.0 | No | Ramp Slope (%) | 10.8 |
| No | Ramp Width (in) | 44.0 | No | Ramp XSlope (%) | 4.9 |

Remove & Replace Curb Ramp With Two New Directional Ramps or Equivalent.

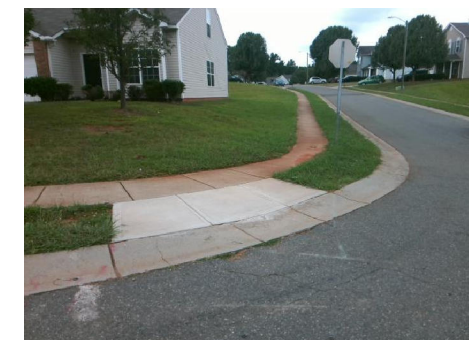
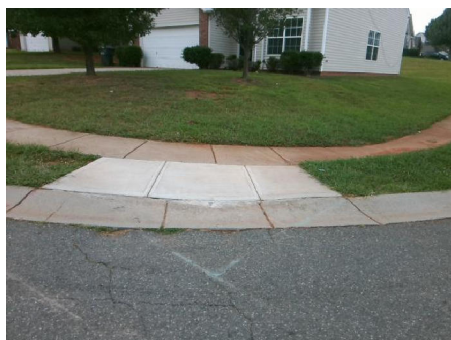
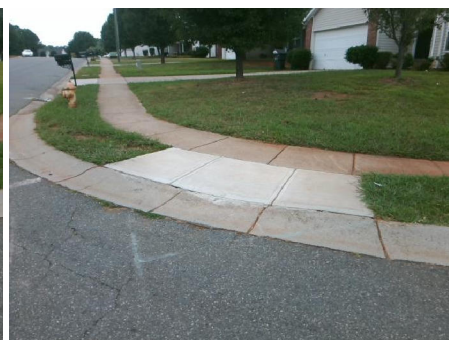
| Compliance | Description | Data | Compliance | Description | Data |
|---|---|---|---|---|---|
| N/A | Gutter Lip Ht (in) | 1.0 | N/A | Gutter X Slope (%) | N/A |
