Access Compliance Report

Public Rights-of-Way

(Curb Ramps)

| Intersection ID: 43353 | Main Street: PROSPERITY RIDGE RD | Cross Street: PROSPERITY COMMONS DR | Location: S |

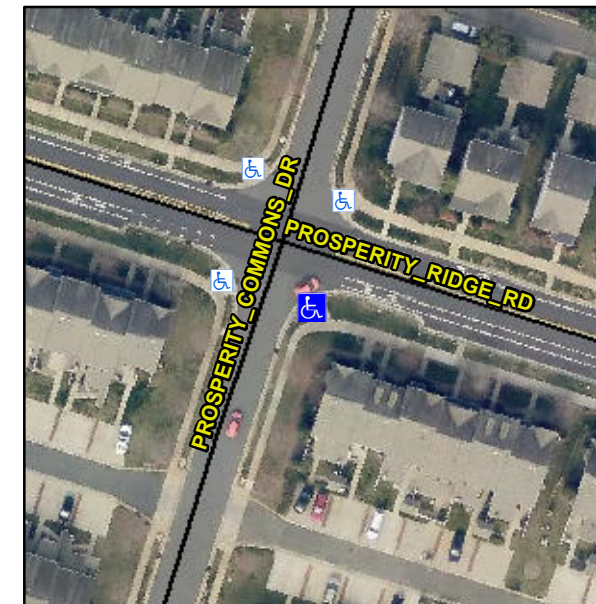
| ADA ID: A35EC2768DAC | Ramp Type: PerpDiag | Initial Pass/Fail: Fail | Overall Compliance: No |
| Severity Score: 35 | | | |

R304.5.1

| Compliance | Description | Data | Compliance | Description | Data |
|---|---|---|---|---|---|
| No | Ramp Width (in) | 31.0 | Yes | Ramp XSlope (%) | 1.0 |

Remove & Replace Curb Ramp With Two New Directional Ramps or Equivalent.

Total Cost: \$ 3200.00
