## **Access Compliance Report Public Rights-of-Way** (Curb Ramps)

Intersection ID: 11308 Main Street: CARDIFF\_AV **Cross Street: SPRINGWAY DR** Location: SE ADA ID: A367E8F50D6F Ramp Type: PerpDiag Initial Pass/Fail: Fail **Overall Compliance: No** Severity Score: 33.75

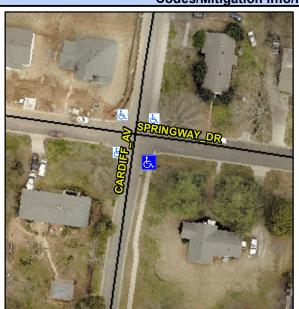
Not Found, R304.5.1, R304.2.2, R304.5.3

Field Measurements/Component Compliance					
Compliance Description		Data	Comp	liance Description	Data
N/A	Ramp Length (in)	50.0	No	Ramp Slope (%)	8.7
No	Ramp Width (in)	46.0	No	Ramp XSlope (%)	6.6
N/A	Flare Type LT	N/A	N/A	Flare Type RT	N/A
N/A	Flare Slope LT (%)	N/A	N/A	Flare Slope RT (%)	N/A
N/A	Flare Traversable LT?	N/A	N/A	Flare Traversable RT?	N/A
N/A	Landing Length (in)	N/A	N/A	DWS Provided?	N/A
N/A	Landing Width (in)	N/A	N/A	DWS Contrast?	N/A
N/A	Landing Slope (%)	N/A	N/A	DWS Length (in)	N/A
N/A	Landing X Slope (%)	N/A	N/A	DWS Full Width?	N/A
N/A	Landing Curb? (Y/N)	N/A	N/A	DWS Offset (in)	N/A
N/A	Shared Landing?	N/A			
N/A	Gutter Ponding?	N/A	N/A	Gutter Slope (%)	N/A
N/A	Gutter Lip Ht (in)	1.0	N/A	Gutter X Slope (%)	N/A
N/A	Painted X Walk1?	No	N/A	Painted X Walk2?	No
	X Walk 1 Direction	To N		X Walk 2 Direction	To W
N/A	X Walk 1 Width (in)	N/A	N/A	X Walk 2 Width (in)	N/A
	X Walk 1 Slope (%)	7.0		X Walk 2 Slope (%)	4.4

X Walk 1 X Slope (%)	1.7		X Walk 2 X Slope (%)	5.4
N/A	Ramp inside XWalk1?	N/A	N/A	Ramp inside XWalk2?	N/A
	Road Slope (%)	7.4	N/A	Clear Space?	N/A
	Road X Slope (%)	1.8	N/A	Clear Space to XWalk (in)	N/A
N/A	Any Obstructions?	N/A	N/A	Storm Grate/Utility Hazard?	N/A
	Obstruction Type			Storm Grate/Utility Type	
		N/A			N/A
			Yes	Surface Condition? (G/P)	Good

Possible Solutions: Remove & Replace Curb Ramp With Two New Directional Ramps or Equivalent. Surveyor Notes: N/A
