# Access Compliance Report

## Public Rights-of-Way

| Intersection ID: 11823 | Main Street: N_ALEXANDER_ST | Cross Street: E_15TH_ST | Location: | N |
| ADA ID: A3722083331E | Ramp Type: Perp | Initial Pass/Fail: Fail | Overall Compliance: No | Severity Score: 10 |

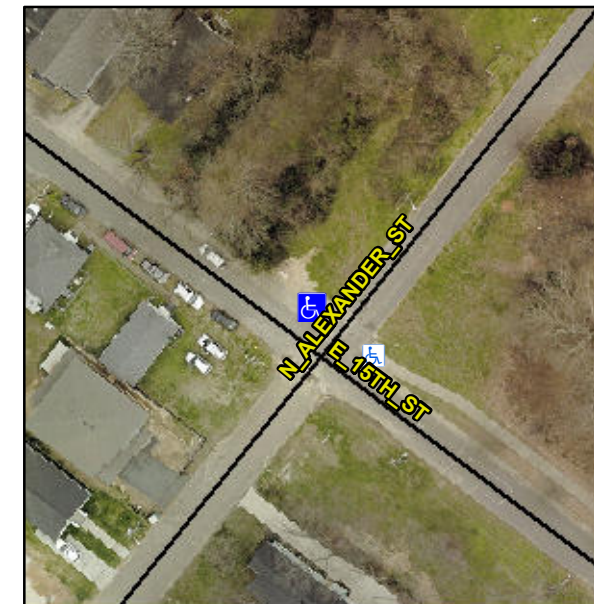
**Not Found, R304.5.1, R304.5.3**

| Compliance | Description | Data | Compliance | Description | Data |
|---|---|---|---|---|---|
| N/A | Ramp Length (in) | 75.0 | Yes | Ramp Slope (%) | 6.7 |
| No | Ramp Width (in) | 47.5 | No | Ramp XSlope (%) | 4.5 |

**Remove & Replace Entire Ramp.**
