Access Compliance Report

Public Rights-of-Way

(Curb Ramps)

Intersection ID: 9391	Main Street: FRANKLIN_AV	Cross Street: OLANDO_ST	Location: NW
ADA ID: A378B4FF39C4	Ramp Type: Para	Initial Pass/Fail: Fail	Overall Compliance: No
Codes/Mitigation Info/Possible Solution		Field Measurements/Component Compliance	
Severity Score: 13.75

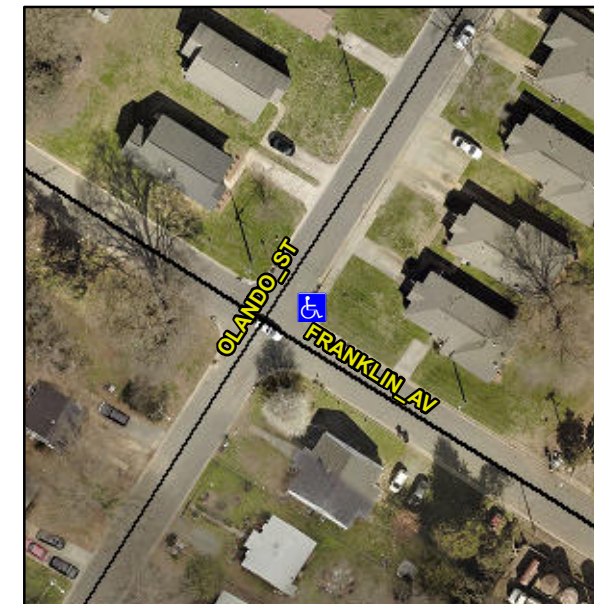
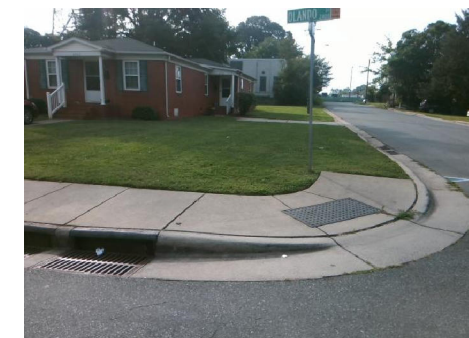
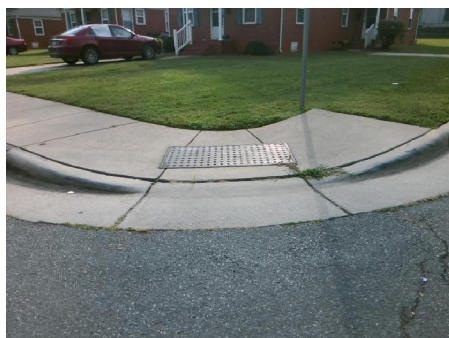
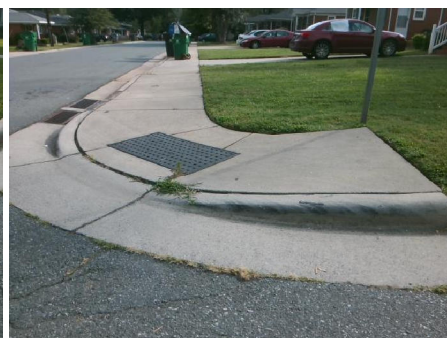
CURB GAP 1.5, LT RP < 5%

R304.5.3, R304.3.2

Compliance	Description	Data	Compliance	Description	Data
N/A	Ramp Length LT (in)	38.0	N/A	Ramp Length RT (in)	45.0
Yes	Ramp Width LT (in)	59.0	Yes	Ramp Width RT (in)	59.0
Yes	Ramp Slope LT (%)	2.2	No	Ramp Slope RT (%)	10.5
No	Ramp XSlope LT (%)	2.2	Yes	Ramp XSlope RT (%)	1.0
N/A	Landing Length (in)	N/A	N/A	DWS Provided?	N/A
N/A	Landing Width (in)	N/A	N/A	DWS Contrast?	N/A
N/A	Landing Slope (%)	N/A	N/A	DWS Length (in)	N/A
N/A	Landing X Slope (%)	N/A	N/A	DWS Full Width?	N/A
N/A	Landing Curb? (Y/N)	N/A	N/A	DWS Offset (in)	N/A
N/A	Shared Landing?	N/A			
N/A	Gutter Ponding?	N/A	N/A	Gutter Slope (%)	N/A
N/A	Gutter Lip Ht (in)	N/A	N/A	Gutter X Slope (%)	N/A
N/A	Painted X Walk1?	No	N/A	Painted X Walk2?	N/A
	X Walk 1 Direction	To SW		X Walk 2 Direction	N/A
N/A	X Walk 1 Width (in)	N/A	N/A	X Walk 2 Width (in)	N/A
	X Walk 1 Slope (%)	0.8		X Walk 2 Slope (%)	N/A
	X Walk 1 X Slope (%)	0.6		X Walk 2 X Slope (%)	N/A
N/A	Ramp inside XWalk1?	N/A	N/A	Ramp inside XWalk2?	N/A

Road Slope (%)	N/A	N/A	Clear Space?	N/A
	Road X Slope (%)	N/A	N/A	Clear Space to XWalk (in)	N/A
N/A	Any Obstructions?	N/A	N/A	Storm Grate/Utility Hazard?	N/A
	Obstruction Type			Storm Grate/Utility Type	
		N/A			N/A
			Yes	Surface Condition? (G/P)	Good
			N/A	Curb Slope (%)	24.4

Remove & Replace Entire Ramp.
