## **Access Compliance Report Public Rights-of-Way** (Curb Ramps)

Intersection ID: 11642 Main Street: N\_POPLAR\_ST Cross Street: W\_9TH\_ST Location: S

**ADA ID: A37F3AA80A4B** Ramp Type: PerpDiag Initial Pass/Fail: Fail **Overall Compliance: No Severity Score:** 25

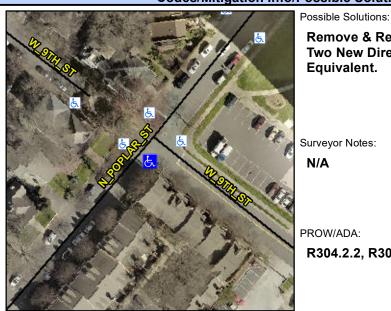
Compliance Description		Data		iance Description	Data
N/A	Ramp Length (in)	55.0	No	Ramp Slope (%)	9.6
Yes	Ramp Width (in)	56.0	No	Ramp XSlope (%)	5.6
N/A	Flare Type LT	N/A	N/A	Flare Type RT	N/A
N/A	Flare Slope LT (%)	N/A	N/A	Flare Slope RT (%)	N/A
N/A	Flare Traversable LT?	N/A	N/A	Flare Traversable RT?	N/A
N/A	Landing Length (in)	N/A	N/A	DWS Provided?	N/A
N/A	Landing Width (in)	N/A	N/A	DWS Contrast?	N/A
N/A	Landing Slope (%)	N/A	N/A	DWS Length (in)	N/A
N/A	Landing X Slope (%)	N/A	N/A	DWS Full Width?	N/A
N/A	Landing Curb? (Y/N)	N/A	N/A	DWS Offset (in)	N/A
N/A	Shared Landing?	N/A			
N/A	Gutter Ponding?	N/A	N/A	Gutter Slope (%)	N/A
N/A	Gutter Lip Ht (in)	N/A	N/A	Gutter X Slope (%)	N/A
N/A	Painted X Walk1?	No	N/A	Painted X Walk2?	No
	X Walk 1 Direction	To NE		X Walk 2 Direction	To NW
N/A	X Walk 1 Width (in)	N/A	N/A	X Walk 2 Width (in)	N/A
	X Walk 1 Slope (%)	9.0		X Walk 2 Slope (%)	4.3
	X Walk 1 X Slope (%)	1.5		X Walk 2 X Slope (%)	0.6

N/A	Ramp inside XWalk1?	N/A	N/A	Ramp inside XWalk2?	N/A
	Road Slope (%)	2.1	N/A	Clear Space?	N/A
	Road X Slope (%)	6.4	N/A	Clear Space to XWalk (in)	N/A
N/A	Any Obstructions?	N/A	N/A	Storm Grate/Utility Hazard?	N/A
	Obstruction Type			Storm Grate/Utility Type	
		N/A			N/A

W 9TH ST Street 1 Name Stop Condition-Street 2 StopSign Street 2 Name **N POPLAR ST** Stop Condition-Street 1 StopSign Remove & Replace Curb Ramp With Two New Directional Ramps or Equivalent.

R304.2.2, R304.5.3
