# Access Compliance Report

## Public Rights-of-Way

### (Curb Ramps)

| Intersection ID: 32248 | Main Street: DENNINGTON GROVE LN | Cross Street: WESTGARTH AV | Location: N |

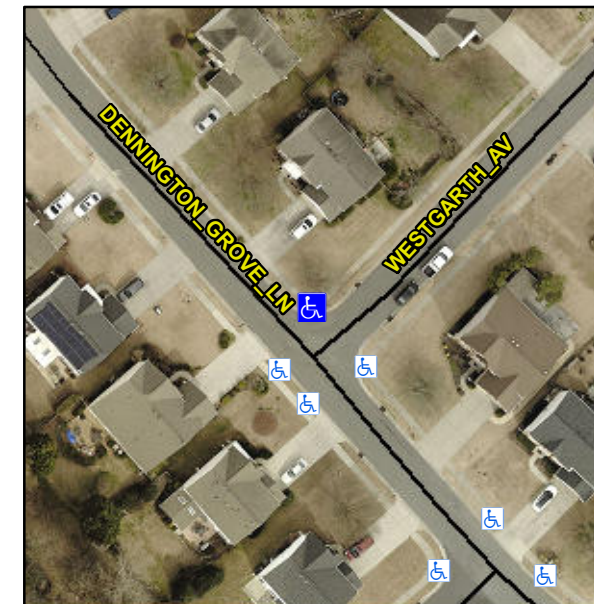
**Not Found, R304.5.3, R304.2.1, R305, R304.5.4**

| Compliance | Description | Data | Compliance | Description | Data |
|---|---|---|---|---|---|
| Yes | Ramp Width (in) | 63.0 | No | BlendTrans XSlope (%) | 3.3 |
| No | Landing Length (in) | 46.0 | No | DWS Provided? | No |
| No | Landing X Slope (%) | 4.0 | N/A | DWS Full Width? | No |
| Yes | Gutter Ponding? | No | No | Gutter Slope (%) | 5.8 |
| Yes | Gutter Lip Ht (in) | 0.0 | No | Gutter X Slope (%) | 3.4 |

**Remove & Replace Curb Ramp With Two New Directional Ramps or Equivalent. Remove & Replace Gutter.**
