Access Compliance Report

Public Rights-of-Way

(Curb Ramps)

Intersection ID: 18381	Main Street: BATHURST_DR	Cross Street: WYALONG_DR	Location: NW
ADA ID: A3A43FF2E359	Ramp Type: Perp	Initial Pass/Fail: Fail	Overall Compliance: No
Codes/Mitigation Info/Possible Solution		Field Measurements/Component Compliance	
Severity Score: 12.5

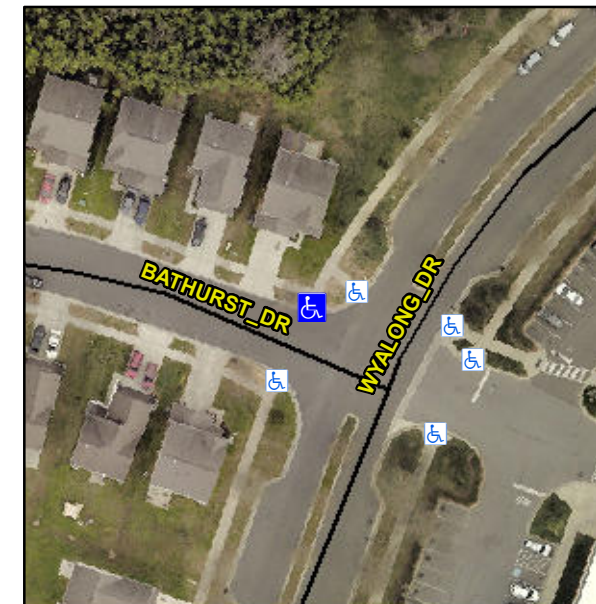
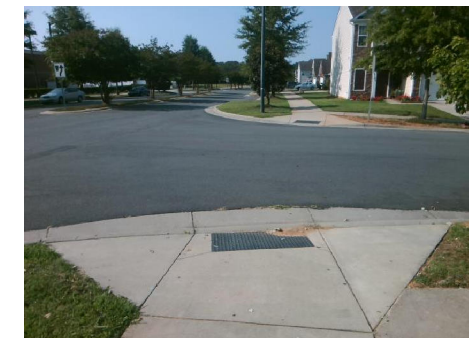
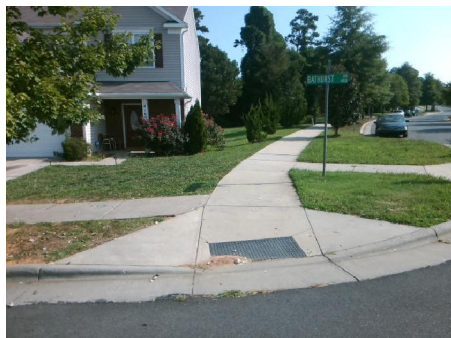
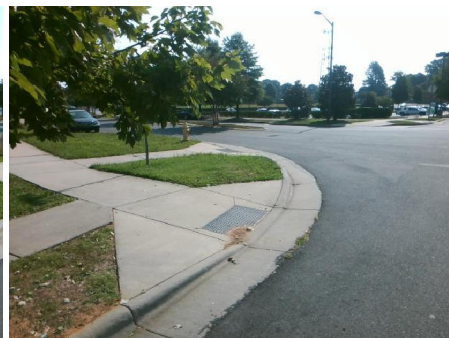
R304.2.2

Compliance	Description	Data	Compliance	Description	Data
N/A	Ramp Length (in)	83.0	No	Ramp Slope (%)	8.8
Yes	Ramp Width (in)	71.0	Yes	Ramp XSlope (%)	0.7
N/A	Flare Type LT	N/A	N/A	Flare Type RT	N/A
N/A	Flare Slope LT (%)	N/A	N/A	Flare Slope RT (%)	N/A
N/A	Flare Traversable LT?	N/A	N/A	Flare Traversable RT?	N/A
N/A	Landing Length (in)	N/A	N/A	DWS Provided?	N/A
N/A	Landing Width (in)	N/A	N/A	DWS Contrast?	N/A
N/A	Landing Slope (%)	N/A	N/A	DWS Length (in)	N/A
N/A	Landing X Slope (%)	N/A	N/A	DWS Full Width?	N/A
N/A	Landing Curb? (Y/N)	N/A	N/A	DWS Offset (in)	N/A
N/A	Shared Landing?	N/A			
N/A	Gutter Ponding?	Yes	N/A	Gutter Slope (%)	N/A
N/A	Gutter Lip Ht (in)	N/A	N/A	Gutter X Slope (%)	N/A
N/A	Painted X Walk1?	No	N/A	Painted X Walk2?	N/A
	X Walk 1 Direction	To SW		X Walk 2 Direction	N/A
N/A	X Walk 1 Width (in)	N/A	N/A	X Walk 2 Width (in)	N/A
	X Walk 1 Slope (%)	1.6		X Walk 2 Slope (%)	N/A
	X Walk 1 X Slope (%)	3.4		X Walk 2 X Slope (%)	N/A

Remove & Replace Entire Ramp.
