Intersection ID: 24095	Main Street: LIVINGSTON_MILL_RD	Cross Street: RED_WINE_CT	Location:	NE
ADA ID: A3A91914BB1D	Ramp Type: PerpDiag	Initial Pass/Fail: Fail	Overall Compliance: No	Severity Score: 33.75

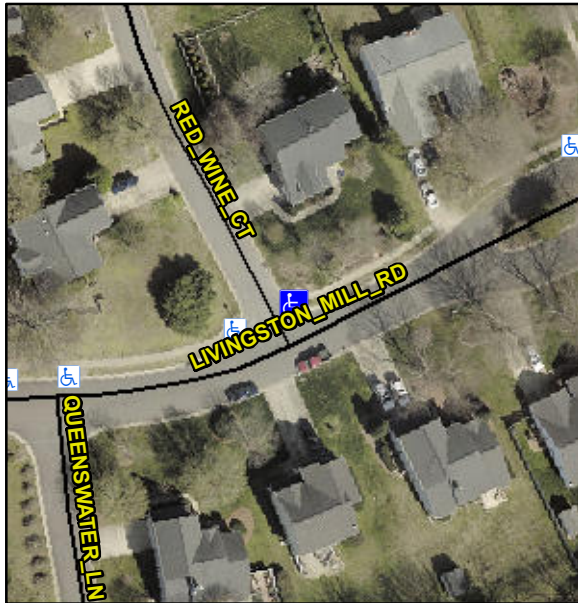
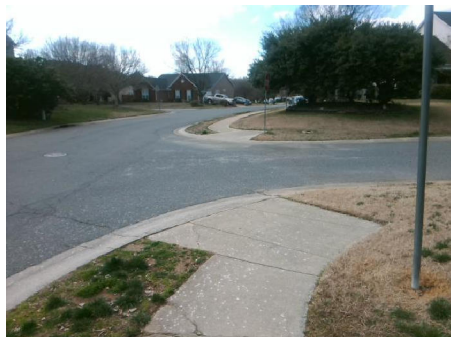
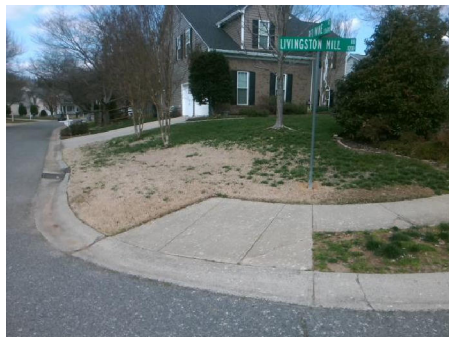
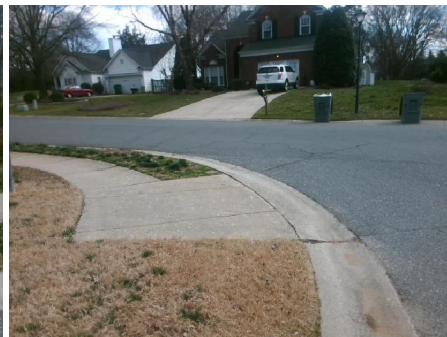
**R304.5.1, R304.2.2, R304.5.3**

Compliance	Description	Data	Compliance	Description	Data
N/A	Ramp Length (in)	94.0	No	Ramp Slope (%)	9.0
No	Ramp Width (in)	46.0	No	Ramp XSlope (%)	5.4
N/A	Flare Type LT	N/A	N/A	Flare Type RT	N/A
N/A	Flare Slope LT (%)	N/A	N/A	Flare Slope RT (%)	N/A
N/A	Flare Traversable LT?	N/A	N/A	Flare Traversable RT?	N/A
N/A	Landing Length (in)	N/A	N/A	DWS Provided?	N/A
N/A	Landing Width (in)	N/A	N/A	DWS Contrast?	N/A
N/A	Landing Slope (%)	N/A	N/A	DWS Length (in)	N/A
N/A	Landing X Slope (%)	N/A	N/A	DWS Full Width?	N/A
N/A	Landing Curb? (Y/N)	N/A	N/A	DWS Offset (in)	N/A
N/A	Shared Landing?	N/A			
N/A	Gutter Ponding?	N/A	N/A	Gutter Slope (%)	N/A
N/A	Gutter Lip Ht (in)	N/A	N/A	Gutter X Slope (%)	N/A
N/A	Painted X Walk1?	No	N/A	Painted X Walk2?	No
	X Walk 1 Direction	To W		X Walk 2 Direction	To S
N/A	X Walk 1 Width (in)	N/A	N/A	X Walk 2 Width (in)	N/A
	X Walk 1 Slope (%)	1.2		X Walk 2 Slope (%)	3.0
	X Walk 1 X Slope (%)	2.3		X Walk 2 X Slope (%)	0.8

N/A	Ramp inside XWalk1?	N/A	N/A	Ramp inside XWalk2?	N/A
	Road Slope (%)	2.3	N/A	Clear Space?	N/A
	Road X Slope (%)	1.5	N/A	Clear Space to XWalk (in)	N/A
N/A	Any Obstructions?	N/A	N/A	Storm Grate/Utility Hazard?	N/A
	Obstruction Type			Storm Grate/Utility Type	
		N/A			N/A
			Yes	Surface Condition? (G/P)	Good

**Remove & Replace Curb Ramp With Two New Directional Ramps or Equivalent.**
