Access Compliance Report

Public Rights-of-Way

(Curb Ramps)

Intersection ID: 31225	Main Street: CLACKWYCK_LN	Cross Street: GRANTHAM_LN	Location:	N
ADA ID: A3BA53BADCA2	Ramp Type: PerpDiag	Initial Pass/Fail: Fail	Overall Compliance: No	Severity Score: 42.5
Codes/Mitigation Info/Possible Solution		Field Measurements/Component Compliance

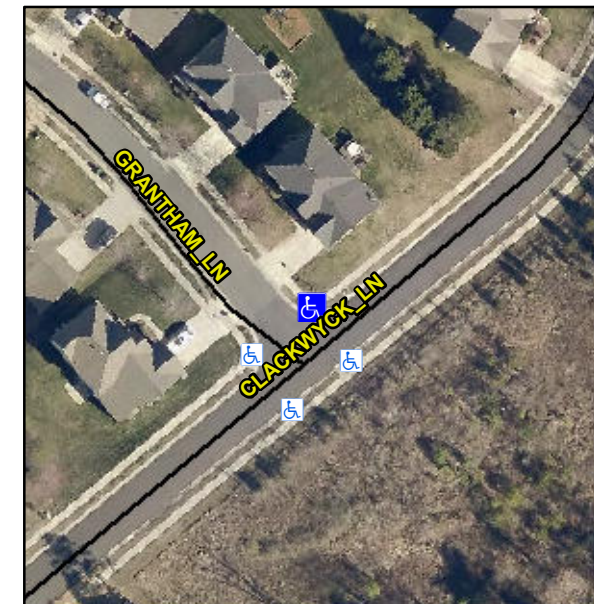
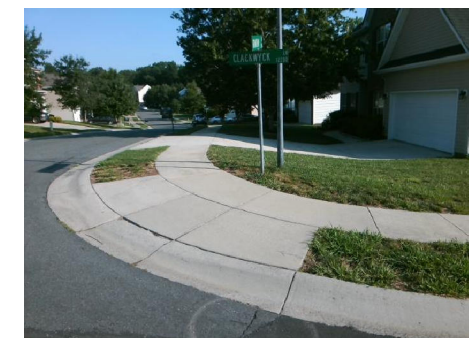
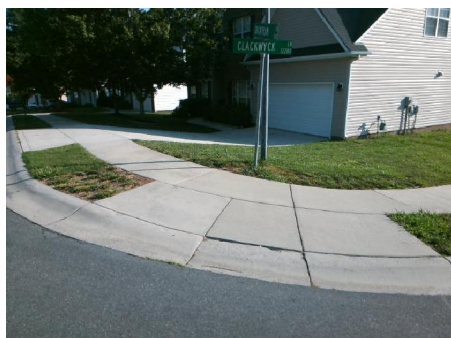
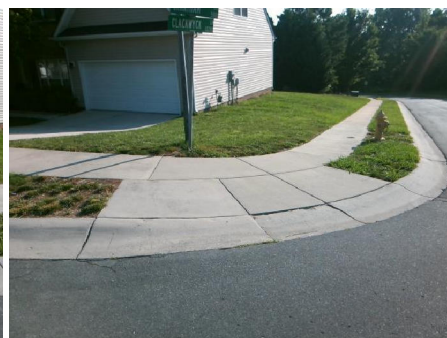
Not Found, R304.5.1, R304.5.3

Compliance	Description	Data	Compliance	Description	Data
N/A	Ramp Length (in)	48.0	Yes	Ramp Slope (%)	5.1
No	Ramp Width (in)	35.0	No	Ramp XSlope (%)	8.6
N/A	Flare Type LT	N/A	N/A	Flare Type RT	N/A
N/A	Flare Slope LT (%)	N/A	N/A	Flare Slope RT (%)	N/A
N/A	Flare Traversable LT?	N/A	N/A	Flare Traversable RT?	N/A
N/A	Landing Length (in)	N/A	N/A	DWS Provided?	N/A
N/A	Landing Width (in)	N/A	N/A	DWS Contrast?	N/A
N/A	Landing Slope (%)	N/A	N/A	DWS Length (in)	N/A
N/A	Landing X Slope (%)	N/A	N/A	DWS Full Width?	N/A
N/A	Landing Curb? (Y/N)	N/A	N/A	DWS Offset (in)	N/A
N/A	Shared Landing?	N/A			
N/A	Gutter Ponding?	N/A	N/A	Gutter Slope (%)	N/A
N/A	Gutter Lip Ht (in)	N/A	N/A	Gutter X Slope (%)	N/A
N/A	Painted X Walk1?	No	N/A	Painted X Walk2?	No
	X Walk 1 Direction	To SW		X Walk 2 Direction	To SE
N/A	X Walk 1 Width (in)	N/A	N/A	X Walk 2 Width (in)	N/A
	X Walk 1 Slope (%)	6.3		X Walk 2 Slope (%)	4.3
	X Walk 1 X Slope (%)	5.7		X Walk 2 X Slope (%)	6.2

N/A	Ramp inside XWalk1?	N/A	N/A	Ramp inside XWalk2?	N/A
	Road Slope (%)	6.5	N/A	Clear Space?	N/A
	Road X Slope (%)	4.9	N/A	Clear Space to XWalk (in)	N/A
N/A	Any Obstructions?	N/A	N/A	Storm Grate/Utility Hazard?	N/A
	Obstruction Type			Storm Grate/Utility Type	
		N/A			N/A
			Yes	Surface Condition? (G/P)	Good

Remove & Replace Curb Ramp With Two New Directional Ramps or Equivalent.
