# Access Compliance Report

## Public Rights-of-Way

### (Curb Ramps)

Intersection ID: 3569	Main Street: OLYMPUS_DR	Cross Street: SHIMMERING LAKE_DR	Location: SE
ADA ID: A3CB96461323	Ramp Type: Perp	Initial Pass/Fail: Fail	Overall Compliance: No
Severity Score: 12.5			
Codes/Mitigation Info/Possible Solution		Field Measurements/Component Compliance

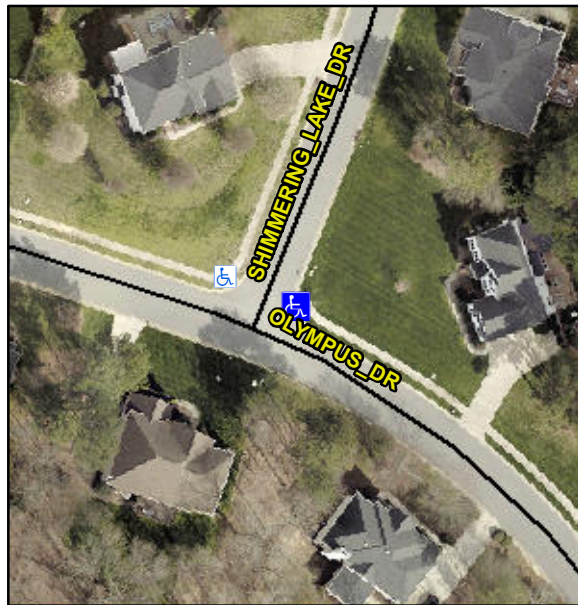
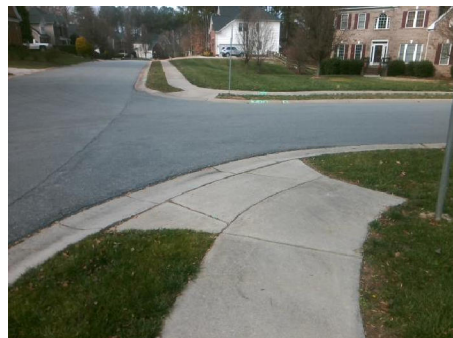
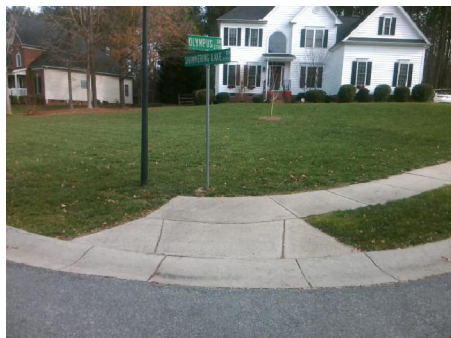
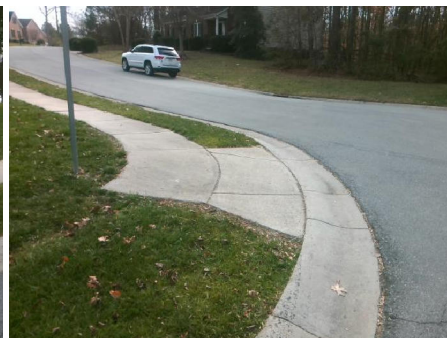
**Not Found, R304.2.2**

Compliance	Description	Data	Compliance	Description	Data
N/A	Ramp Length (in)	41.0	No	Ramp Slope (%)	8.7
Yes	Ramp Width (in)	56.0	Yes	Ramp XSlope (%)	2.0
N/A	Flare Type LT	N/A	N/A	Flare Type RT	N/A
N/A	Flare Slope LT (%)	N/A	N/A	Flare Slope RT (%)	N/A
N/A	Flare Traversable LT?	N/A	N/A	Flare Traversable RT?	N/A
N/A	Landing Length (in)	N/A	N/A	DWS Provided?	N/A
N/A	Landing Width (in)	N/A	N/A	DWS Contrast?	N/A
N/A	Landing Slope (%)	N/A	N/A	DWS Length (in)	N/A
N/A	Landing X Slope (%)	N/A	N/A	DWS Full Width?	N/A
N/A	Landing Curb? (Y/N)	N/A	N/A	DWS Offset (in)	N/A
N/A	Shared Landing?	N/A			
N/A	Gutter Ponding?	N/A	N/A	Gutter Slope (%)	N/A
N/A	Gutter Lip Ht (in)	N/A	N/A	Gutter X Slope (%)	N/A
N/A	Painted X Walk1?	No	N/A	Painted X Walk2?	N/A
	X Walk 1 Direction	To NW		X Walk 2 Direction	N/A
N/A	X Walk 1 Width (in)	N/A	N/A	X Walk 2 Width (in)	N/A
	X Walk 1 Slope (%)	1.9		X Walk 2 Slope (%)	N/A
	X Walk 1 X Slope (%)	0.9		X Walk 2 X Slope (%)	N/A

N/A	Ramp inside XWalk1?	N/A	N/A	Ramp inside XWalk2?	N/A
	Road Slope (%)	N/A	N/A	Clear Space?	N/A
	Road X Slope (%)	N/A	N/A	Clear Space to XWalk (in)	N/A
N/A	Any Obstructions?	N/A	N/A	Storm Grate/Utility Hazard?	N/A
	Obstruction Type			Storm Grate/Utility Type	
		N/A			N/A
			Yes	Surface Condition? (G/P)	Good

**Remove & Replace Entire Ramp.**
