Access Compliance Report

Public Rights-of-Way

(Curb Ramps)

| Intersection ID: 26629 | Main Street: ALPINE_FOREST_CT | Cross Street: MANOR_HOUSE_DR | Location: NW |

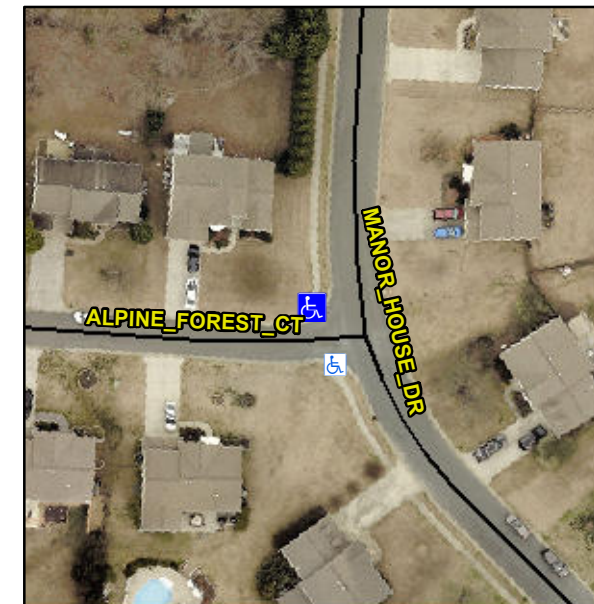
| ADA ID: A3CC7A138614 | Ramp Type: Perp | Initial Pass/Fail: Fail | Overall Compliance: No |
| | | Severity Score: 1.25 | |

Not Found, R304.5.3

| Compliance | Description | Data | Compliance | Description | Data |
|---|---|---|---|---|---|
| N/A | Ramp Length (in) | 48.0 | Yes | Ramp Slope (%) | 6.3 |
| Yes | Ramp Width (in) | 48.0 | No | Ramp XSlope (%) | 3.6 |

Possible Solutions:

Remove & Replace Entire Ramp.

Total Cost: \$ 1850.00
