# Access Compliance Report

## Public Rights-of-Way

### (Curb Ramps)

Intersection ID: 12833	Main Street: HICKORY GROVE RD	Cross Street: VALLEYVIEW DR	Location: NW
ADA ID: A3D67F47622C	Ramp Type: Perp	Initial Pass/Fail: Fail	Overall Compliance: No
		Severity Score: 12.5

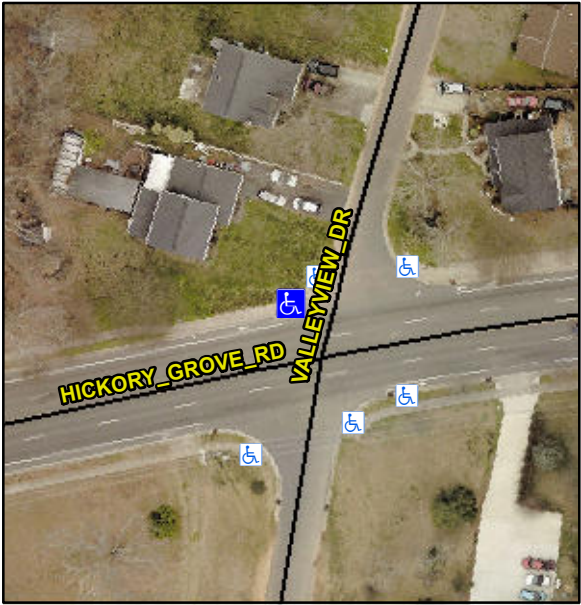
Possible Solutions:		<b>Compliance</b>	<b>Description</b>	<b>Data</b>
	Remove & Replace Entire Ramp.		<b>No</b>	Ramp Length (in)	60.5
			<b>Yes</b>	Ramp Width (in)	48.0
			<b>N/A</b>	Flare Type LT	N/A
			<b>N/A</b>	Flare Slope LT (%)	N/A
			<b>N/A</b>	Flare Traversable LT?	N/A
			<b>N/A</b>	Landing Length (in)	N/A
			<b>N/A</b>	Landing Width (in)	N/A
			<b>N/A</b>	Landing Slope (%)	N/A
			<b>N/A</b>	Landing X Slope (%)	N/A
<p>Surveyor Notes:</p> <p><b>N/A</b></p> <p>PROW/ADA:</p> <p><b>Not Found, R304.2.2</b></p>			<b>N/A</b>	Flare Type RT	N/A
			<b>N/A</b>	Flare Slope RT (%)	N/A
			<b>N/A</b>	Flare Traversable RT?	N/A
			<b>N/A</b>	DWS Provided?	N/A
			<b>N/A</b>	DWS Contrast?	N/A
			<b>N/A</b>	DWS Length (in)	N/A
			<b>N/A</b>	DWS Full Width?	N/A
			<b>N/A</b>	DWS Offset (in)	N/A
			<b>N/A</b>	Shared Landing?	N/A
			<b>N/A</b>	Gutter Ponding?	N/A

<b>N/A</b>	Gutter Lip Ht (in)	N/A
			<b>No</b>	Painted X Walk1?	N/A
				X Walk 1 Direction	To S
			<b>N/A</b>	X Walk 1 Width (in)	N/A
				X Walk 1 Slope (%)	2.6
				X Walk 1 X Slope (%)	1.0
			<b>N/A</b>	Ramp inside XWalk1?	N/A
			<b>N/A</b>	Road Slope (%)	N/A
			<b>N/A</b>	Road X Slope (%)	N/A
			<b>N/A</b>	Any Obstructions?	N/A
				Obstruction Type	
			<b>N/A</b>		
			<b>N/A</b>		
			<b>N/A</b>		
			<b>N/A</b>		
			<b>N/A</b>		
			<b>N/A</b>		
			<b>N/A</b>		
			<b>N/A</b>		
			<b>N/A</b>		
Total Cost:		\$ 1850.00			
			<b>N/A</b>		
			<b>Yes</b>	Surface Condition? (G/P)	Good
