## **Access Compliance Report Public Rights-of-Way** (Curb Ramps)

Intersection ID: 10608 Main Street: N\_DAVIDSON\_ST Cross Street: JORDAN PL Location: N Ramp Type: BlendTrans1 Initial Pass/Fail: Fail **Overall Compliance: No Severity Score:** 8.75 ADA ID: A3DA660E7519

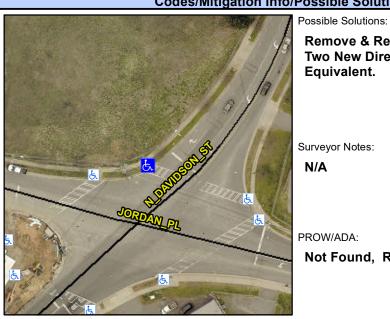
Piela Measurements/Component Compilance					
Compliance Description		Data	Compliance Description		Data
N/A	Ramp Length (in)	71.0	Yes	BlendTrans Slope (%)	3.6
No	Ramp Width (in)	43.0	Yes	BlendTrans XSlope (%)	0.5
N/A	Flare Type LT	N/A	N/A	Flare Type RT	N/A
N/A	Flare Slope LT (%)	N/A	N/A	Flare Slope RT (%)	N/A
N/A	Flare Traversable LT?	N/A	N/A	Flare Traversable RT?	N/A
N/A	Landing Length (in)	N/A	N/A	DWS Provided?	N/A
N/A	Landing Width (in)	N/A	N/A	DWS Contrast?	N/A
N/A	Landing Slope (%)	N/A	N/A	DWS Length (in)	N/A
N/A	Landing X Slope (%)	N/A	N/A	DWS Full Width?	N/A
N/A	Landing Curb? (Y/N)	N/A	N/A	DWS Offset (in)	N/A
N/A	Shared Landing?	N/A			
N/A	Gutter Ponding?	N/A	N/A	Gutter Slope (%)	N/A
N/A	Gutter Lip Ht (in)	N/A	N/A	Gutter X Slope (%)	N/A
N/A	Painted X Walk1?	Yes	N/A	Painted X Walk2?	N/A
	X Walk 1 Direction	To SE		X Walk 2 Direction	N/A
	X Walk 1 Width (in)	117.5		X Walk 2 Width (in)	N/A
	X Walk 1 Slope (%)	1.8		X Walk 2 Slope (%)	N/A

X Walk 1 X Slope (%)	0.5		X Walk 2 X Slope (%)	N/A
N/A	Ramp inside XWalk1?	Yes	N/A	Ramp inside XWalk2?	N/A
	Road Slope (%)	0.5		Clear Space?	N/A
	Road X Slope (%)	1.8	N/A	Clear Space to XWalk (in)	N/A
N/A	Any Obstructions?	N/A	N/A	Storm Grate/Utility Hazard?	N/A
	Obstruction Type			Storm Grate/Utility Type	
		N/A			N/A
			Yes	Surface Condition? (G/P)	Good
870			No	Curb Slope (%)	30.1

N DAVIDSON ST Street 1 Name Signal Stop Condition-Street 1 Street 2 Name N/A Stop Condition-Street 2 N/A Remove & Replace Curb Ramp With **Two New Directional Ramps or** Equivalent.

Not Found, R304.5.1
