Access Compliance Report Public Rights-of-Way (Curb Ramps)

Intersection ID: 12257 Main Street: W_3RD_ST Cross Street: S_POPLAR_ST Location: E

ADA ID: A3E64BC89C6A Ramp Type: PerpDiag Initial Pass/Fail: Fail Overall Compliance: No Severity Score: 12.5

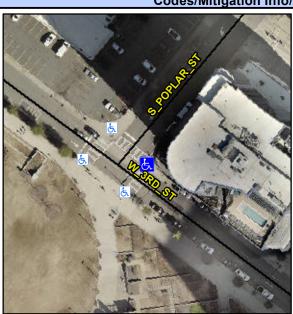
Compli	iance Description	Data	Compli	iance [Description	Data
N/A	Ramp Length (in)	73.0	No	Ramp S	Slope (%)	8.8
Yes	Ramp Width (in)	59.0	Yes	Ramp >	KSlope (%)	1.3
N/A	Flare Type LT	N/A	N/A	Flare T	ype RT	N/A
N/A	Flare Slope LT (%)	N/A	N/A	Flare S	lope RT (%)	N/A
N/A	Flare Traversable LT?	N/A	N/A	Flare Ti	raversable RT?	N/A
N/A	Landing Length (in)	N/A	N/A	DWS P	rovided?	N/A
N/A	Landing Width (in)	N/A	N/A	DWS C	Contrast?	N/A
N/A	Landing Slope (%)	N/A	N/A	DWS L	ength (in)	N/A
N/A	Landing X Slope (%)	N/A	N/A	DWS F	ull Width?	N/A
N/A	Landing Curb? (Y/N)	N/A	N/A	DWS O	Offset (in)	N/A
N/A	Shared Landing?	N/A				
N/A	Gutter Ponding?	N/A	N/A	Gutter	Slope (%)	N/A
N/A	Gutter Lip Ht (in)	N/A	N/A	Gutter 2	X Slope (%)	N/A
N/A	Painted X Walk1?	Yes	N/A	Painted	d X Walk2?	Yes
	X Walk 1 Direction	To NW		X Walk	2 Direction	To SW
N/A	X Walk 1 Width (in)	114.5	N/A	X Walk	2 Width (in)	120.0
	X Walk 1 Slope (%)	3.6		X Walk	2 Slope (%)	2.3

X Walk 1 X Slope (%)	1.9		X Walk	2 X Slope (%)	2.5
N/A	Ramp inside XWalk1?	Yes	N/A	Ramp i	nside XWalk2?	Yes
	Road Slope (%)	1.9	N/A	Clear S	Space?	N/A
	Road X Slope (%)	2.5	N/A	Clear S	Space to XWalk (in)	N/A
N/A	Any Obstructions?	N/A	N/A	Storm (Grate/Utility Hazard?	N/A
	Obstruction Type			Storm (Grate/Utility Type	
		N/A				N/A

Remove & Replace Curb Ramp With Two New Directional Ramps or Equivalent.

Total Cost: \$ 3200.00
