# Access Compliance Report

## Public Rights-of-Way

### (Curb Ramps)

Intersection ID: N/A	Main Street: MILLENNIUM_AV	Cross Street: POTOMAC_RIVER_PY	Location: SE
ADA ID: A3E829156DAD	Ramp Type: Directional1	Initial Pass/Fail: Fail	Overall Compliance: No
Severity Score: 13.75			
Codes/Mitigation Info/Possible Solution		Field Measurements/Component Compliance

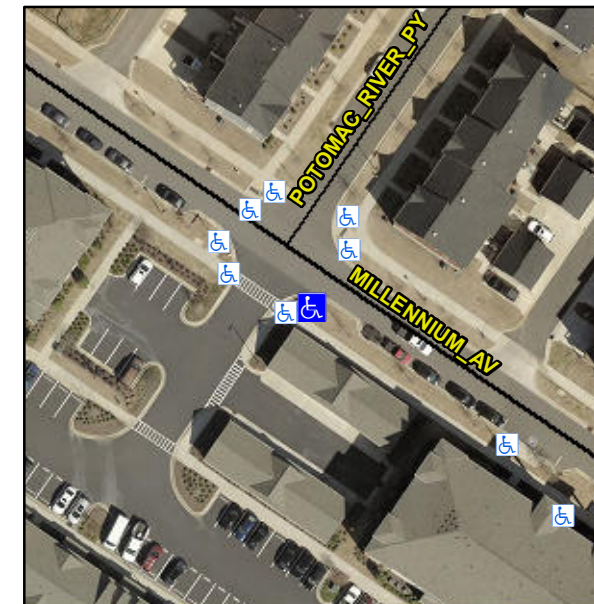
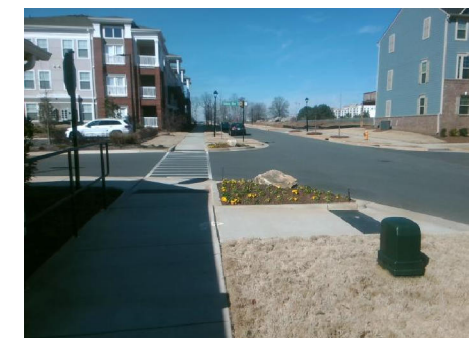
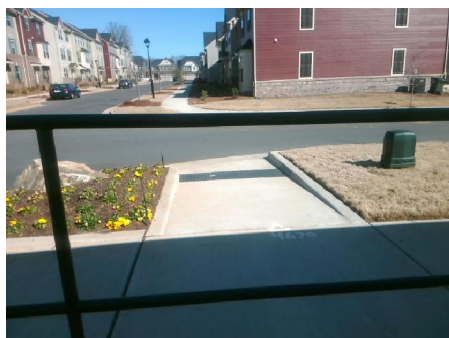
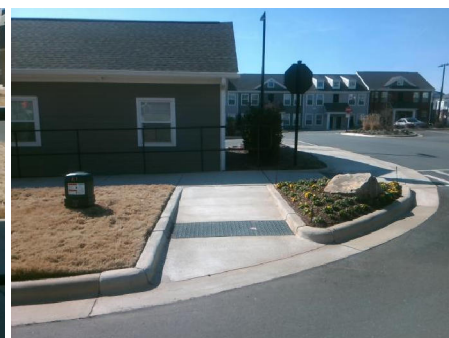
Compliance	Description	Data	Compliance	Description	Data
N/A	Ramp Length (in)	113.0	N/A	Grade Break?	N/A
Yes	Ramp Width (in)	72.0	N/A	Grade Break Slope (%)	0.0
No	Ramp Slope (%)	8.6	N/A	Grade Break XSlope (%)	0.0
No	Ramp XSlope (%)	3.2			
N/A	Flare Type LT	N/A	N/A	Flare Type RT	N/A
N/A	Flare Slope LT (%)	N/A	N/A	Flare Slope RT (%)	0.0
N/A	Flare Traversable LT?	N/A	N/A	Flare Traversable RT?	N/A
N/A	Landing Length (in)	0.0	N/A	DWS Provided?	N/A
N/A	Landing Width (in)	0.0	N/A	DWS Contrast?	N/A
N/A	Landing Slope (%)	0.0	N/A	DWS Length (in)	N/A
N/A	Landing X Slope (%)	0.0	N/A	DWS Full Width?	N/A
N/A	Landing Curb? (Y/N)	N/A	N/A	DWS Offset LT (in)	N/A
N/A	Shared Landing?	N/A	N/A	DWS Offset RT (in)	N/A
N/A	Gutter Ponding?	0.0	N/A	Gutter Slope (%)	N/A
N/A	Gutter Lip Ht (in)	0.0	N/A	Gutter X Slope (%)	N/A
N/A	Painted X Walk1?	No		Road Slope (%)	1.0
	X Walk 1 Direction	To NE		Road X Slope (%)	1.7
	X Walk 1 Width (in)	N/A		Clear Space?	N/A

X Walk 1 Slope (%)	1.0	N/A	Clear Space to XWalk (in)	N/A
	X Walk 1 X Slope (%)	1.7	N/A	Storm Grate/Utility Hazard?	N/A
N/A	Ramp inside XWalk1?	N/A		Storm Grate/Utility Type	
N/A	Any Obstructions?	N/A			N/A
	Obstruction Type		Yes	Surface Condition? (G/P)	Good
			N/A	Curb Slope (%)	2.5

**Remove & Replace Entire Ramp.**

**R304.2.2, R304.5.3**
