# Access Compliance Report

## Public Rights-of-Way

### (Curb Ramps)

Intersection ID: 15178	Main Street: DILWORTH_RD_EAST	Cross Street: IDEAL_WY	Location: SW
ADA ID: A3ED3E376822	Ramp Type: Perp	Initial Pass/Fail: Fail	Overall Compliance: No
Severity Score: 1.25			
Codes/Mitigation Info/Possible Solution		Field Measurements/Component Compliance

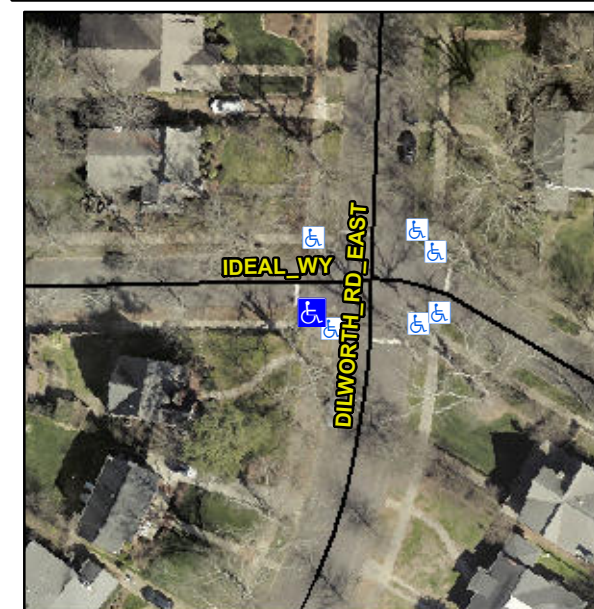
**Not Found, R304.5.3**

Compliance	Description	Data	Compliance	Description	Data
N/A	Ramp Length (in)	77.0	Yes	Ramp Slope (%)	8.0
Yes	Ramp Width (in)	60.0	No	Ramp XSlope (%)	4.3
N/A	Flare Type LT	N/A	N/A	Flare Type RT	N/A
N/A	Flare Slope LT (%)	N/A	N/A	Flare Slope RT (%)	N/A
N/A	Flare Traversable LT?	N/A	N/A	Flare Traversable RT?	N/A
N/A	Landing Length (in)	N/A	N/A	DWS Provided?	N/A
N/A	Landing Width (in)	N/A	N/A	DWS Contrast?	N/A
N/A	Landing Slope (%)	N/A	N/A	DWS Length (in)	N/A
N/A	Landing X Slope (%)	N/A	N/A	DWS Full Width?	N/A
N/A	Landing Curb? (Y/N)	N/A	N/A	DWS Offset (in)	N/A
N/A	Shared Landing?	N/A			
N/A	Gutter Ponding?	N/A	N/A	Gutter Slope (%)	N/A
N/A	Gutter Lip Ht (in)	1.0	N/A	Gutter X Slope (%)	N/A
N/A	Painted X Walk1?	No	N/A	Painted X Walk2?	N/A
	X Walk 1 Direction	To N		X Walk 2 Direction	N/A
N/A	X Walk 1 Width (in)	N/A	N/A	X Walk 2 Width (in)	N/A
	X Walk 1 Slope (%)	3.7		X Walk 2 Slope (%)	N/A
	X Walk 1 X Slope (%)	1.9		X Walk 2 X Slope (%)	N/A

N/A	Ramp inside XWalk1?	N/A	N/A	Ramp inside XWalk2?	N/A
	Road Slope (%)	N/A	N/A	Clear Space?	N/A
	Road X Slope (%)	N/A	N/A	Clear Space to XWalk (in)	N/A
N/A	Any Obstructions?	N/A	N/A	Storm Grate/Utility Hazard?	N/A
	Obstruction Type			Storm Grate/Utility Type	
		N/A			N/A
		Yes		Surface Condition? (G/P)	Good

Possible Solutions:

**Remove & Replace Entire Ramp.**

Total Cost: \$ 1850.00
