Access Compliance Report

Public Rights-of-Way

(Curb Ramps)

Intersection ID: 21462	Main Street: OAKSTONE_PL	Cross Street: WOODSTREAM_DR	Location: SW
ADA ID: A3F11E811FB9	Ramp Type: PerpDiag	Initial Pass/Fail: Fail	Overall Compliance: No
		Severity Score: 10

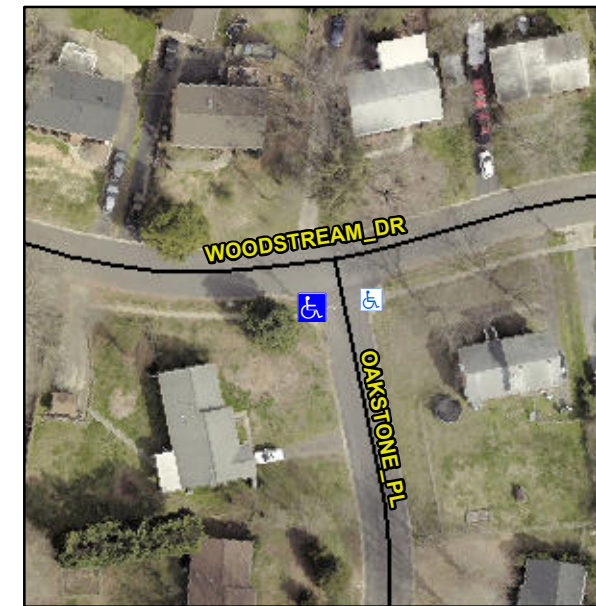
Not Found, R304.5.1, R304.5.3

Compliance	Description	Data	Compliance	Description	Data
N/A	Ramp Length (in)	57.0	Yes	Ramp Slope (%)	7.0
No	Ramp Width (in)	47.0	No	Ramp XSlope (%)	3.9
N/A	Flare Type LT	N/A	N/A	Flare Type RT	N/A
N/A	Flare Slope LT (%)	N/A	N/A	Flare Slope RT (%)	N/A
N/A	Flare Traversable LT?	N/A	N/A	Flare Traversable RT?	N/A
N/A	Landing Length (in)	N/A	N/A	DWS Provided?	N/A
N/A	Landing Width (in)	N/A	N/A	DWS Contrast?	N/A
N/A	Landing Slope (%)	N/A	N/A	DWS Length (in)	N/A
N/A	Landing X Slope (%)	N/A	N/A	DWS Full Width?	N/A
N/A	Landing Curb? (Y/N)	N/A	N/A	DWS Offset (in)	N/A
N/A	Shared Landing?	N/A			
N/A	Gutter Ponding?	N/A	N/A	Gutter Slope (%)	N/A
N/A	Gutter Lip Ht (in)	N/A	N/A	Gutter X Slope (%)	N/A
N/A	Painted X Walk1?	No	N/A	Painted X Walk2?	No
	X Walk 1 Direction	To E		X Walk 2 Direction	To N
N/A	X Walk 1 Width (in)	N/A	N/A	X Walk 2 Width (in)	N/A
	X Walk 1 Slope (%)	0.2		X Walk 2 Slope (%)	2.3
	X Walk 1 X Slope (%)	2.8		X Walk 2 X Slope (%)	2.4

N/A	Ramp inside XWalk1?	N/A	N/A	Ramp inside XWalk2?	N/A
	Road Slope (%)	2.4	N/A	Clear Space?	N/A
	Road X Slope (%)	0.3	N/A	Clear Space to XWalk (in)	N/A
N/A	Any Obstructions?	N/A	N/A	Storm Grate/Utility Hazard?	N/A
	Obstruction Type			Storm Grate/Utility Type	
		N/A			N/A
		Yes		Surface Condition? (G/P)	Good

Remove & Replace Curb Ramp With Two New Directional Ramps or Equivalent.

Total Cost: \$ 3200.00
