Access Compliance Report

Public Rights-of-Way

(Curb Ramps)

Intersection ID: 16520	Main Street: S_TRYON_ST	Cross Street: ORCHARD_CR	Location:	N
ADA ID: A3F3189CEF9E	Ramp Type: PerpDiag	Initial Pass/Fail: Fail	Overall Compliance: No	Severity Score: 22.5
Codes/Mitigation Info/Possible Solution		Field Measurements/Component Compliance

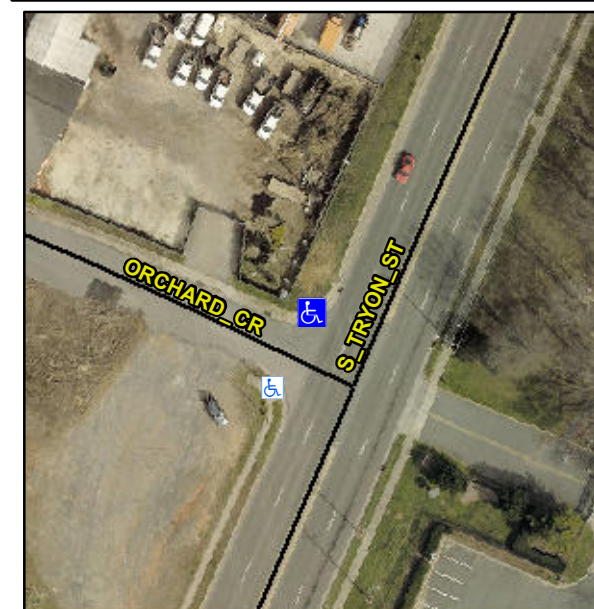
Not Found, R304.5.1, R304.2.2, R304.5.3

Compliance	Description	Data	Compliance	Description	Data
N/A	Ramp Length (in)	70.0	No	Ramp Slope (%)	10.6
No	Ramp Width (in)	39.0	No	Ramp XSlope (%)	4.3
N/A	Flare Type LT	N/A	N/A	Flare Type RT	N/A
N/A	Flare Slope LT (%)	N/A	N/A	Flare Slope RT (%)	N/A
N/A	Flare Traversable LT?	N/A	N/A	Flare Traversable RT?	N/A
N/A	Landing Length (in)	N/A	N/A	DWS Provided?	N/A
N/A	Landing Width (in)	N/A	N/A	DWS Contrast?	N/A
N/A	Landing Slope (%)	N/A	N/A	DWS Length (in)	N/A
N/A	Landing X Slope (%)	N/A	N/A	DWS Full Width?	N/A
N/A	Landing Curb? (Y/N)	N/A	N/A	DWS Offset (in)	N/A
N/A	Shared Landing?	N/A			
N/A	Gutter Ponding?	N/A	N/A	Gutter Slope (%)	N/A
N/A	Gutter Lip Ht (in)	1.5	N/A	Gutter X Slope (%)	N/A
N/A	Painted X Walk1?	No	N/A	Painted X Walk2?	No
	X Walk 1 Direction	To SW		X Walk 2 Direction	To SE
N/A	X Walk 1 Width (in)	N/A	N/A	X Walk 2 Width (in)	N/A
	X Walk 1 Slope (%)	4.2		X Walk 2 Slope (%)	3.5
	X Walk 1 X Slope (%)	2.9		X Walk 2 X Slope (%)	3.9

N/A	Ramp inside XWalk1?	N/A	N/A	Ramp inside XWalk2?	N/A
	Road Slope (%)	1.4	N/A	Clear Space?	N/A
	Road X Slope (%)	5.2	N/A	Clear Space to XWalk (in)	N/A
N/A	Any Obstructions?	N/A	N/A	Storm Grate/Utility Hazard?	N/A
	Obstruction Type			Storm Grate/Utility Type	
		N/A			N/A
			Yes	Surface Condition? (G/P)	Good

Remove & Replace Curb Ramp With Two New Directional Ramps or Equivalent.
