Access Compliance Report

Public Rights-of-Way

(Curb Ramps)

Intersection ID: N/A	Main Street: REACROFT_DR	Cross Street: HUNTSCROFT_LN	Location: SW
ADA ID: A3FAE12F8281	Ramp Type: Perp	Initial Pass/Fail: Fail	Overall Compliance: No
Severity Score: 21.25			
Codes/Mitigation Info/Possible Solution		Field Measurements/Component Compliance

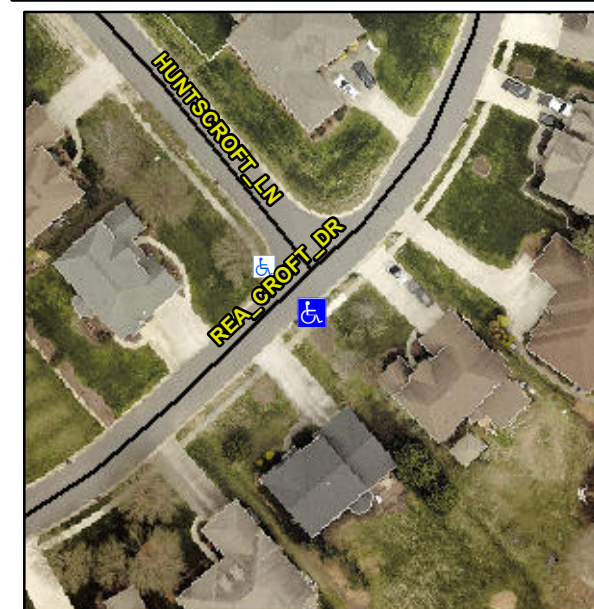
Not Found, R304.5.1, R304.2.2

Compliance	Description	Data	Compliance	Description	Data
N/A	Ramp Length (in)	49.0	No	Ramp Slope (%)	10.1
No	Ramp Width (in)	46.0	Yes	Ramp XSlope (%)	1.7
N/A	Flare Type LT	N/A	N/A	Flare Type RT	N/A
N/A	Flare Slope LT (%)	N/A	N/A	Flare Slope RT (%)	N/A
N/A	Flare Traversable LT?	N/A	N/A	Flare Traversable RT?	N/A
N/A	Landing Length (in)	N/A	N/A	DWS Provided?	N/A
N/A	Landing Width (in)	N/A	N/A	DWS Contrast?	N/A
N/A	Landing Slope (%)	N/A	N/A	DWS Length (in)	N/A
N/A	Landing X Slope (%)	N/A	N/A	DWS Full Width?	N/A
N/A	Landing Curb? (Y/N)	N/A	N/A	DWS Offset (in)	N/A
N/A	Shared Landing?	N/A			
N/A	Gutter Ponding?	N/A	N/A	Gutter Slope (%)	N/A
N/A	Gutter Lip Ht (in)	N/A	N/A	Gutter X Slope (%)	N/A
N/A	Painted X Walk1?	No	N/A	Painted X Walk2?	N/A
	X Walk 1 Direction	To NW		X Walk 2 Direction	N/A
N/A	X Walk 1 Width (in)	N/A	N/A	X Walk 2 Width (in)	N/A
	X Walk 1 Slope (%)	3.7		X Walk 2 Slope (%)	N/A
	X Walk 1 X Slope (%)	2.0		X Walk 2 X Slope (%)	N/A

N/A	Ramp inside XWalk1?	N/A	N/A	Ramp inside XWalk2?	N/A
	Road Slope (%)	N/A	N/A	Clear Space?	N/A
	Road X Slope (%)	N/A	N/A	Clear Space to XWalk (in)	N/A
N/A	Any Obstructions?	N/A	N/A	Storm Grate/Utility Hazard?	N/A
	Obstruction Type			Storm Grate/Utility Type	
		N/A			N/A
			Yes	Surface Condition? (G/P)	Good

Possible Solutions:

Remove & Replace Entire Ramp.
