## Access Compliance Report Public Rights-of-Way (Curb Ramps)

Intersection ID: 44221	ntersection ID: 44221 Main Street: ATHERTON_MILL_RD			Cross Street: RICHARD_ROZZELLE_DR				Location:	NE
ADA ID: A3FE6BBB97	88 Ramp Type: PerpDiag			Initial Pass/Fail: Fail Overall Compliance: N				o Severity Score:	10
Codes/Mitigation Info/Possible Solution				Field Measurements/Component Compliance

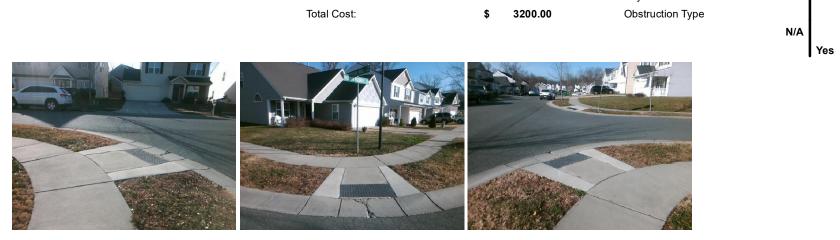
-	Possible Solutions:		Compliance Description		Data	Data Compliance Description		
		Remove & Replace Curb Ramp	With	N/A	Ramp Length (in)	73.0	Yes	Ramp Slope (%)	5.3
		Two New Directional Ramps or Equivalent.		No	Ramp Width (in)	40.5	No	Ramp XSlope (%)	2.4
				N/A	Flare Type LT	N/A	N/A	Flare Type RT	N/A

- I I I			N/A	Flare Slope LT (%)	N/A	N/A	Flare Slope RT (%)	N/A
E				N/A	Flare Traversable LT?	N/A	N/A	Flare Traversable RT?	N/A
				N/A	Landing Length (in)	N/A	N/A	DWS Provided?	N/A
		Surveyor Notes:		N/A	Landing Width (in)	N/A	N/A	DWS Contrast?	N/A
	THELE DR 6	N/A		N/A	Landing Slope (%)	N/A	N/A	DWS Length (in)	N/A
		174		N/A	Landing X Slope (%)	N/A	N/A	DWS Full Width?	N/A
RIGHTER				N/A	Landing Curb? (Y/N)	N/A	N/A	DWS Offset (in)	N/A
				N/A	Shared Landing?	N/A	1		
		PROW/ADA:		N/A	Gutter Ponding?	N/A	N/A	Gutter Slope (%)	N/A
Sampellin 200				N/A	Gutter Lip Ht (in)	N/A	N/A	Gutter X Slope (%)	N/A
		R304.5.1, R304.5.3		N/A	Painted X Walk1?	N/A No	N/A	Painted X Walk2?	N/A No
PROW/ADA: R304.5.1, R304.5.3				N/A	X Walk 1 Direction	To W	N/A	X Walk 2 Direction	To S
				N/A		-	<b>N</b> 1/A		
				N/A	X Walk 1 Width (in)	N/A	N/A	X Walk 2 Width (in)	N/A
Street 1 Name	ATHERTON MILL RD				X Walk 1 Slope (%)	4.0		X Walk 2 Slope (%)	12.1

Stop Condition-Street 2	StopSign				X Walk 1 X Slope (%)	4.8		X Walk 2 X Slope (%)	2.9
Street 2 Name	RICHARD ROZZELLE DR			N/A	Ramp inside XWalk1?	N/A	N/A	Ramp inside XWalk2?	N/A
Stop Condition-Street 1	None				Road Slope (%)	0.3	N/A	Clear Space?	N/A
					Road X Slope (%)	9.5	N/A	Clear Space to XWalk (in)	N/A
				N/A	Any Obstructions?	N/A	N/A	Storm Grate/Utility Hazard?	N/A
		Total Cost: \$	3200.00		Obstruction Type			Storm Grate/Utility Type	
						N/A			N/A
