Access Compliance Report Public Rights-of-Way (Curb Ramps)

Intersection ID: 52442 Main Street: WOODWARD_AV Cross Street: BENDING_BIRCH_PL Location: W

ADA ID: A402F4F6FD52 Ramp Type: Directional1 Initial Pass/Fail: Pass Overall Compliance: No Severity Score: 20.25

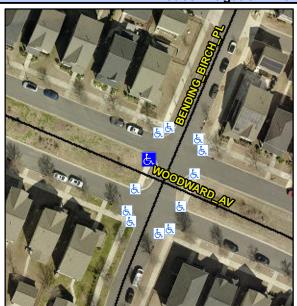
/Possible Solution	
Possible Solutions:	Co
Remove & Replace Entire Ramp.	N/A
Remove & Replace Gutter.	Yes
	Yes
	Yes
	Yes
	N/A
Surveyor Notes:	N/A
LOCATED ON MEDIAN	Yes
	Yes
	Yes
	Yes
PROW/ADA:	N/A
R304.5.3, R302.7.2, R304.5.4	N/A
	Yes
	No
	N/A
