Access Compliance Report Public Rights-of-Way (Curb Ramps)

Intersection ID: 31896Main Street: GREEN_MOUNTAIN_RDCross Street: SHOPTON_RD_WESTLocation:NWADA ID: A40CC0DB7E6FRamp Type: PerpDiagInitial Pass/Fail: FailOverall Compliance: NoSeverity Score:10

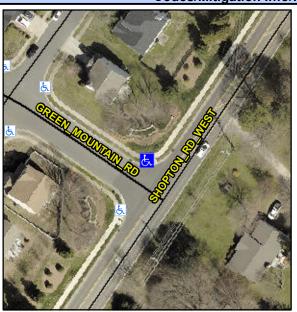
Not Found, R304.5.1, R304.5.3

r leid Measurements/Component Compnance						
	Comp	Compliance Description		Comp	liance Description	Data
	N/A	Ramp Length (in)	48.0	Yes	Ramp Slope (%)	5.3
	No	Ramp Width (in)	47.0	No	Ramp XSlope (%)	2.8
	N/A	Flare Type LT	N/A	N/A	Flare Type RT	N/A
	N/A	Flare Slope LT (%)	N/A	N/A	Flare Slope RT (%)	N/A
	N/A	Flare Traversable LT?	N/A	N/A	Flare Traversable RT?	N/A
	N/A	Landing Length (in)	N/A	N/A	DWS Provided?	N/A
	N/A	Landing Width (in)	N/A	N/A	DWS Contrast?	N/A
	N/A	Landing Slope (%)	N/A	N/A	DWS Length (in)	N/A
	N/A	Landing X Slope (%)	N/A	N/A	DWS Full Width?	N/A
	N/A	Landing Curb? (Y/N)	N/A	N/A	DWS Offset (in)	N/A
	N/A	Shared Landing?	N/A			
	N/A	Gutter Ponding?	N/A	N/A	Gutter Slope (%)	N/A
	N/A	Gutter Lip Ht (in)	N/A	N/A	Gutter X Slope (%)	N/A
	N/A	Painted X Walk1?	No	N/A	Painted X Walk2?	No
		X Walk 1 Direction	To SW		X Walk 2 Direction	To SE
	N/A	X Walk 1 Width (in)	N/A	N/A	X Walk 2 Width (in)	N/A
		X Walk 1 Slope (%)	0.7		X Walk 2 Slope (%)	1.2

X Walk 1 X Slope (%)	0.8		X Walk 2 X Slope (%)	2.0
	N/A	Ramp inside XWalk1?	N/A	N/A	Ramp inside XWalk2?	N/A
		Road Slope (%)	3.0	N/A	Clear Space?	N/A
		Road X Slope (%)	1.3	N/A	Clear Space to XWalk (in)	N/A
	N/A	Any Obstructions?	N/A	N/A	Storm Grate/Utility Hazard?	N/A
		Obstruction Type			Storm Grate/Utility Type	
			N/A			N/A

Remove & Replace Curb Ramp With
Two New Directional Ramps or
Equivalent.
