Access Compliance Report Public Rights-of-Way (Curb Ramps)

Intersection ID: 12165 Main Street: E_15TH_ST Cross Street: HARRILL_ST Location: N

ADA ID: A413011CA3CB Ramp Type: BlendTrans2 Initial Pass/Fail: Pass Overall Compliance: No Severity Score: 20.25

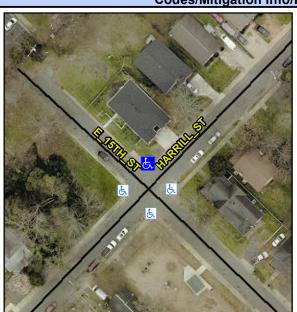
NO CURB LINE

Compliance Description Data Compliance Description Yes N/A Ramp Length (in) 62.0 BlendTrans Slope (%) No Yes Ramp Width (in) 48.0 BlendTrans XSlope (%) Flare Type RT N/A Flare Type LT Sloped N/A Flare Slope LT (%) Yes Flare Slope RT (%) No 10.7 N/A Flare Traversable LT? Yes N/A Flare Traversable RT? N/A N/A No DWS Provided? Landing Length (in) N/A Landing Width (in) N/A N/A **DWS Contrast?** N/A N/A N/A Landing Slope (%) DWS Length (in) N/A Landing X Slope (%) N/A N/A DWS Full Width? N/A Landing Curb? (Y/N) No N/A DWS Offset (in) N/A Shared Landing? No **Gutter Ponding?** Yes Gutter Slope (%) Yes No No Gutter Lip Ht (in) 0.5 No Gutter X Slope (%) N/A Painted X Walk1? No N/A Painted X Walk2? X Walk 1 Direction To SW X Walk 2 Direction N/A X Walk 1 Width (in) X Walk 2 Width (in) X Walk 1 Slope (%) 3.0 X Walk 2 Slope (%) X Walk 1 X Slope (%) 4.2 X Walk 2 X Slope (%) N/A N/A Ramp inside XWalk2? N/A Ramp inside XWalk1? Road Slope (%) 4.0 Clear Space?

Remove & Replace Curb Ramp With
Two New Directional Ramps or
Equivalent. Remove & Replace
Gutter.

PROW/ADA: R304.5.3, R304.2.3, R305, R302.7.2
