# Access Compliance Report

## Public Rights-of-Way

### (Curb Ramps)

Intersection ID: 49136	Main Street: AMBER_LEIGH_WAY_DR	Cross Street: POPE_FARM_RD	Location: W
ADA ID: A42A2F1D3693	Ramp Type: Perp	Initial Pass/Fail: Fail	Overall Compliance: No
Severity Score: 22.5			
Codes/Mitigation Info/Possible Solution		Field Measurements/Component Compliance

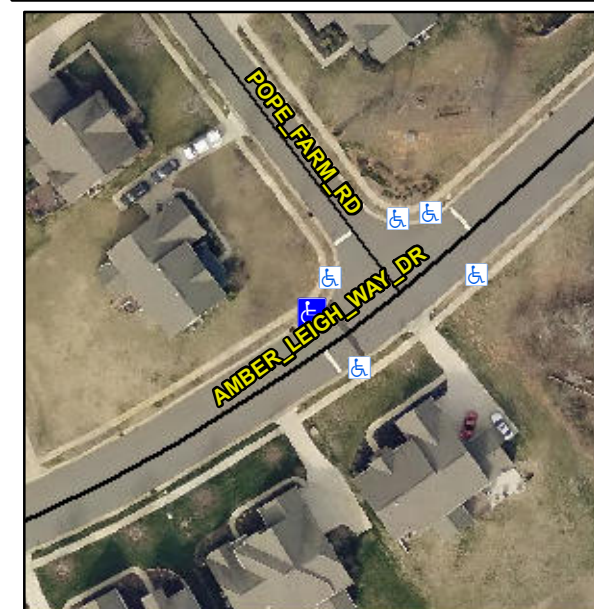
**R304.5.1, R304.2.2, R304.5.3**

Compliance	Description	Data	Compliance	Description	Data
N/A	Ramp Length (in)	48.0	No	Ramp Slope (%)	10.4
No	Ramp Width (in)	47.5	No	Ramp XSlope (%)	2.1
N/A	Flare Type LT	N/A	N/A	Flare Type RT	N/A
N/A	Flare Slope LT (%)	N/A	N/A	Flare Slope RT (%)	N/A
N/A	Flare Traversable LT?	N/A	N/A	Flare Traversable RT?	N/A
N/A	Landing Length (in)	N/A	N/A	DWS Provided?	N/A
N/A	Landing Width (in)	N/A	N/A	DWS Contrast?	N/A
N/A	Landing Slope (%)	N/A	N/A	DWS Length (in)	N/A
N/A	Landing X Slope (%)	N/A	N/A	DWS Full Width?	N/A
N/A	Landing Curb? (Y/N)	N/A	N/A	DWS Offset (in)	N/A
N/A	Shared Landing?	N/A			
N/A	Gutter Ponding?	N/A	N/A	Gutter Slope (%)	N/A
N/A	Gutter Lip Ht (in)	N/A	N/A	Gutter X Slope (%)	N/A
N/A	Painted X Walk1?	No	N/A	Painted X Walk2?	N/A
	X Walk 1 Direction	To SE		X Walk 2 Direction	N/A
N/A	X Walk 1 Width (in)	N/A	N/A	X Walk 2 Width (in)	N/A
	X Walk 1 Slope (%)	2.8		X Walk 2 Slope (%)	N/A
	X Walk 1 X Slope (%)	1.1		X Walk 2 X Slope (%)	N/A

N/A	Ramp inside XWalk1?	N/A	N/A	Ramp inside XWalk2?	N/A
	Road Slope (%)	N/A	N/A	Clear Space?	N/A
	Road X Slope (%)	N/A	N/A	Clear Space to XWalk (in)	N/A
N/A	Any Obstructions?	N/A	N/A	Storm Grate/Utility Hazard?	N/A
	Obstruction Type			Storm Grate/Utility Type	
		N/A			N/A
			Yes	Surface Condition? (G/P)	Good

**Remove & Replace Entire Ramp.**
