Access Compliance Report

Public Rights-of-Way

(Curb Ramps)

Intersection ID: N/A	Main Street: BRECKFIELD_CT	Cross Street: SHETLAND_LN	Location: NW
ADA ID: A4583BE3FCE9	Ramp Type: PerpDiag	Initial Pass/Fail: Fail	Overall Compliance: No
			Severity Score: 21.25

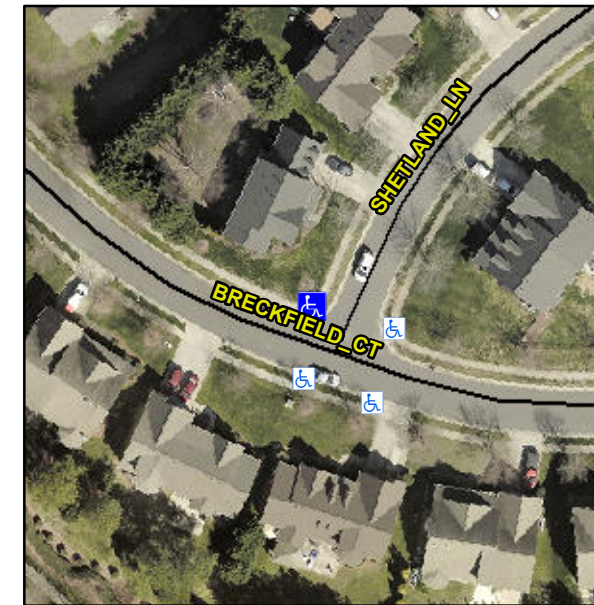
Compliance	Description	Data	Compliance	Description	Data
N/A	Ramp Length (in)	49.0	No	Ramp Slope (%)	10.8
No	Ramp Width (in)	45.5	Yes	Ramp XSlope (%)	1.3
N/A	Flare Type LT	N/A	N/A	Flare Type RT	N/A
N/A	Flare Slope LT (%)	N/A	N/A	Flare Slope RT (%)	N/A
N/A	Flare Traversable LT?	N/A	N/A	Flare Traversable RT?	N/A
N/A	Landing Length (in)	N/A	N/A	DWS Provided?	N/A
N/A	Landing Width (in)	N/A	N/A	DWS Contrast?	N/A
N/A	Landing Slope (%)	N/A	N/A	DWS Length (in)	N/A
N/A	Landing X Slope (%)	N/A	N/A	DWS Full Width?	N/A
N/A	Landing Curb? (Y/N)	N/A	N/A	DWS Offset (in)	N/A
N/A	Shared Landing?	N/A			
N/A	Gutter Ponding?	N/A	N/A	Gutter Slope (%)	N/A
N/A	Gutter Lip Ht (in)	N/A	N/A	Gutter X Slope (%)	N/A
N/A	Painted X Walk1?	No	N/A	Painted X Walk2?	No
	X Walk 1 Direction	To SW		X Walk 2 Direction	To SE
N/A	X Walk 1 Width (in)	N/A	N/A	X Walk 2 Width (in)	N/A
	X Walk 1 Slope (%)	1.4		X Walk 2 Slope (%)	2.1
	X Walk 1 X Slope (%)	2.2		X Walk 2 X Slope (%)	0.4

N/A	Ramp inside XWalk1?	N/A	N/A	Ramp inside XWalk2?	N/A
	Road Slope (%)	1.9	N/A	Clear Space?	N/A
	Road X Slope (%)	2.1	N/A	Clear Space to XWalk (in)	N/A
N/A	Any Obstructions?	N/A	N/A	Storm Grate/Utility Hazard?	N/A
	Obstruction Type			Storm Grate/Utility Type	
		N/A			N/A
			Yes	Surface Condition? (G/P)	Good

Remove & Replace Curb Ramp With Two New Directional Ramps or Equivalent.
