# Access Compliance Report

## Public Rights-of-Way

Intersection ID: 12611	Main Street: S_CHURCH_ST	Cross Street: W_STONEWALL_ST	Location: S
ADA ID: A46C4116F412	Ramp Type: PerpDiag	Initial Pass/Fail: Fail	Overall Compliance: No
Severity Score: 31.25			
Codes/Mitigation Info/Possible Solution		Field Measurements/Component Compliance

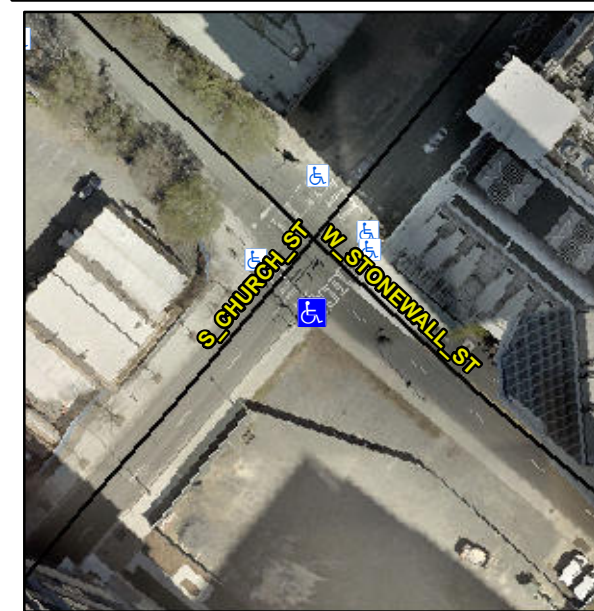
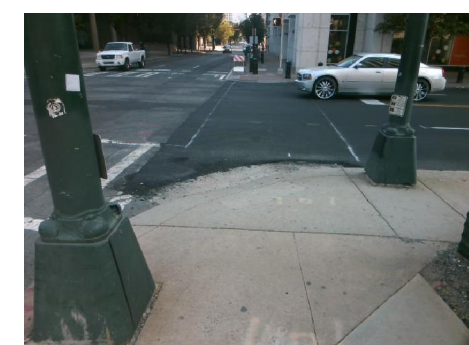
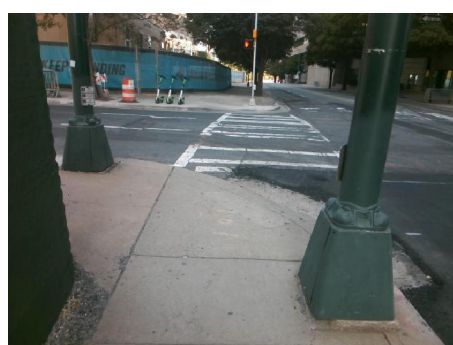
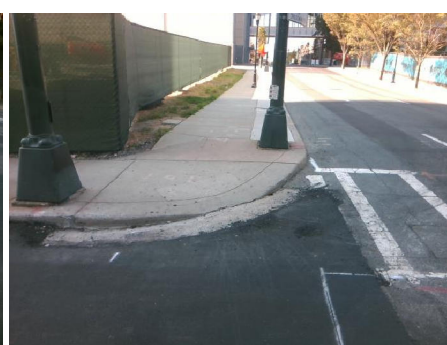
**Not Found, R304.5.1, R304.2.2**

Compliance	Description	Data	Compliance	Description	Data
N/A	Ramp Length (in)	51.0	No	Ramp Slope (%)	10.7
No	Ramp Width (in)	33.0	Yes	Ramp XSlope (%)	2.8
N/A	Flare Type LT	N/A	N/A	Flare Type RT	N/A
N/A	Flare Slope LT (%)	N/A	N/A	Flare Slope RT (%)	N/A
N/A	Flare Traversable LT?	N/A	N/A	Flare Traversable RT?	N/A
N/A	Landing Length (in)	N/A	N/A	DWS Provided?	N/A
N/A	Landing Width (in)	N/A	N/A	DWS Contrast?	N/A
N/A	Landing Slope (%)	N/A	N/A	DWS Length (in)	N/A
N/A	Landing X Slope (%)	N/A	N/A	DWS Full Width?	N/A
N/A	Landing Curb? (Y/N)	N/A	N/A	DWS Offset (in)	N/A
N/A	Shared Landing?	N/A			
N/A	Gutter Ponding?	N/A	N/A	Gutter Slope (%)	N/A
N/A	Gutter Lip Ht (in)	N/A	N/A	Gutter X Slope (%)	N/A
N/A	Painted X Walk1?	No	N/A	Painted X Walk2?	Yes
	X Walk 1 Direction	To NE		X Walk 2 Direction	To NW
N/A	X Walk 1 Width (in)	N/A	N/A	X Walk 2 Width (in)	110.0
	X Walk 1 Slope (%)	0.9		X Walk 2 Slope (%)	7.6
	X Walk 1 X Slope (%)	2.8		X Walk 2 X Slope (%)	0.3

N/A	Ramp inside XWalk1?	N/A	N/A	Ramp inside XWalk2?	Yes
	Road Slope (%)	2.8	N/A	Clear Space?	N/A
	Road X Slope (%)	4.6	N/A	Clear Space to XWalk (in)	N/A
N/A	Any Obstructions?	N/A	N/A	Storm Grate/Utility Hazard?	N/A
	Obstruction Type			Storm Grate/Utility Type	
		N/A			N/A
		Yes		Surface Condition? (G/P)	Good

Possible Solutions:

**Remove & Replace Curb Ramp With Two New Directional Ramps or Equivalent.**

Total Cost: \$ 3200.00
