Access Compliance Report

Public Rights-of-Way

(Curb Ramps)

Intersection ID: 26143	Main Street: CARMEL_RD	Cross Street: SEVILLA_CT	Location:	N
ADA ID: A46CF7E72911	Ramp Type: PerpDiag	Initial Pass/Fail: Fail	Overall Compliance: No	Severity Score: 12.5

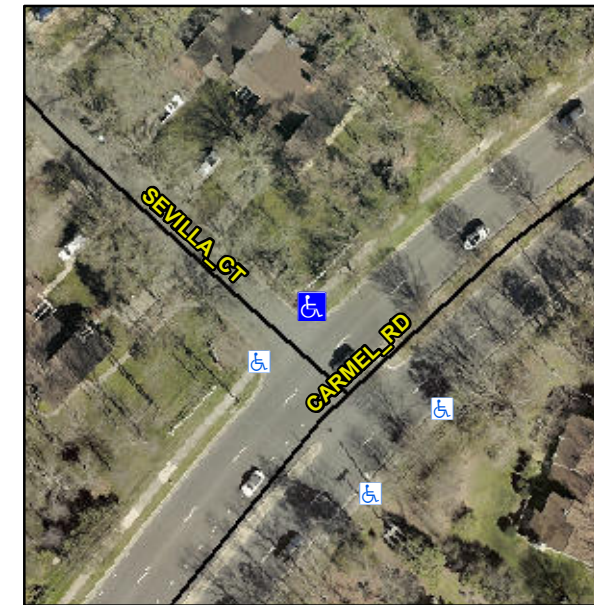
Not Found, R304.5.3

Compliance	Description	Data	Compliance	Description	Data
N/A	Ramp Length (in)	103.0	Yes	Ramp Slope (%)	7.1
Yes	Ramp Width (in)	48.0	No	Ramp XSlope (%)	6.3
N/A	Flare Type LT	N/A	N/A	Flare Type RT	N/A
N/A	Flare Slope LT (%)	N/A	N/A	Flare Slope RT (%)	N/A
N/A	Flare Traversable LT?	N/A	N/A	Flare Traversable RT?	N/A
N/A	Landing Length (in)	N/A	N/A	DWS Provided?	N/A
N/A	Landing Width (in)	N/A	N/A	DWS Contrast?	N/A
N/A	Landing Slope (%)	N/A	N/A	DWS Length (in)	N/A
N/A	Landing X Slope (%)	N/A	N/A	DWS Full Width?	N/A
N/A	Landing Curb? (Y/N)	N/A	N/A	DWS Offset (in)	N/A
N/A	Shared Landing?	N/A			
N/A	Gutter Ponding?	N/A	N/A	Gutter Slope (%)	N/A
N/A	Gutter Lip Ht (in)	N/A	N/A	Gutter X Slope (%)	N/A
N/A	Painted X Walk1?	No	N/A	Painted X Walk2?	No
	X Walk 1 Direction	To SW		X Walk 2 Direction	To SE
N/A	X Walk 1 Width (in)	N/A	N/A	X Walk 2 Width (in)	N/A
	X Walk 1 Slope (%)	1.3		X Walk 2 Slope (%)	7.9
	X Walk 1 X Slope (%)	6.9		X Walk 2 X Slope (%)	3.6

N/A	Ramp inside XWalk1?	N/A	N/A	Ramp inside XWalk2?	N/A
	Road Slope (%)	4.0	N/A	Clear Space?	N/A
	Road X Slope (%)	7.9	N/A	Clear Space to XWalk (in)	N/A
N/A	Any Obstructions?	N/A	N/A	Storm Grate/Utility Hazard?	N/A
	Obstruction Type			Storm Grate/Utility Type	
		N/A			N/A
		Yes		Surface Condition? (G/P)	Good

Remove & Replace Curb Ramp With Two New Directional Ramps or Equivalent.
