## **Access Compliance Report Public Rights-of-Way** (Curb Ramps)

Main Street: OAKTON HUNT DR **Cross Street: WRAYHILL DR** Location: Intersection ID: 31202 Ν Ramp Type: PerpDiag Initial Pass/Fail: Fail **Overall Compliance: No** 22.5 ADA ID: A46F7E64D2AD **Severity Score:**

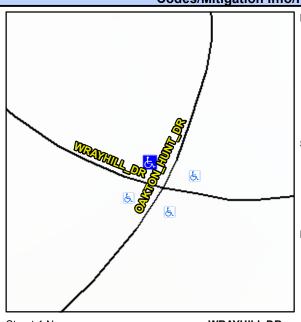
Compli	iance Description	Data	Compl	iance	Description	Data
N/A	Ramp Length (in)	70.0	No	Ram	o Slope (%)	9.6
No	Ramp Width (in)	38.0	No	Ramp	xSlope (%)	4.5
N/A	Flare Type LT	N/A	N/A	Flare	Type RT	N/A
N/A	Flare Slope LT (%)	N/A	N/A	Flare	Slope RT (%)	N/A
N/A	Flare Traversable LT?	N/A	N/A	Flare	Traversable RT?	N/A
N/A	Landing Length (in)	N/A	N/A	DWS	Provided?	N/A
N/A	Landing Width (in)	N/A	N/A	DWS	Contrast?	N/A
N/A	Landing Slope (%)	N/A	N/A	DWS	Length (in)	N/A
N/A	Landing X Slope (%)	N/A	N/A	DWS	Full Width?	N/A
N/A	Landing Curb? (Y/N)	N/A	N/A	DWS	Offset (in)	N/A
N/A	Shared Landing?	N/A				
N/A	Gutter Ponding?	N/A	N/A	Gutte	er Slope (%)	N/A
N/A	Gutter Lip Ht (in)	N/A	N/A	Gutte	er X Slope (%)	N/A
N/A	Painted X Walk1?	No	N/A	Paint	ed X Walk2?	No
	X Walk 1 Direction	To SW		X Wa	lk 2 Direction	To SE
N/A	X Walk 1 Width (in)	N/A	N/A	X Wa	ılk 2 Width (in)	N/A
	X Walk 1 Slope (%)	4.7		X Wa	ılk 2 Slope (%)	3.2
	X Walk 1 X Slope (%)	3.0		X Wa	ılk 2 X Slope (%)	9.8

Possible Solutions: Remove & Replace Curb Ramp With Two New Directional Ramps or Equivalent. Surveyor Notes: N/A PROW/ADA: Not Found, R304.5.1, R304.2.2, R304.5.3
