Access Compliance Report

Public Rights-of-Way

(Curb Ramps)

Intersection ID: 47468	Main Street: MILLSTREAM RIDGE DR	Cross Street: ELENLIL LN	Location: SE
ADA ID: A4704883B106	Ramp Type: Perp	Initial Pass/Fail: Fail	Overall Compliance: No
Severity Score: 60			
Codes/Mitigation Info/Possible Solution		Field Measurements/Component Compliance

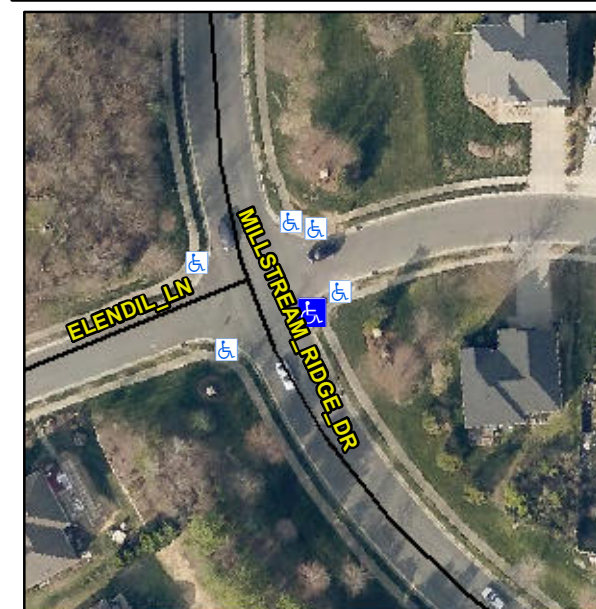
R304.5.1, R304.2.2, R304.5.3

Compliance	Description	Data	Compliance	Description	Data
N/A	Ramp Length (in)	55.0	No	Ramp Slope (%)	8.7
No	Ramp Width (in)	26.0	No	Ramp XSlope (%)	6.9
N/A	Flare Type LT	N/A	N/A	Flare Type RT	N/A
N/A	Flare Slope LT (%)	N/A	N/A	Flare Slope RT (%)	N/A
N/A	Flare Traversable LT?	N/A	N/A	Flare Traversable RT?	N/A
N/A	Landing Length (in)	N/A	N/A	DWS Provided?	N/A
N/A	Landing Width (in)	N/A	N/A	DWS Contrast?	N/A
N/A	Landing Slope (%)	N/A	N/A	DWS Length (in)	N/A
N/A	Landing X Slope (%)	N/A	N/A	DWS Full Width?	N/A
N/A	Landing Curb? (Y/N)	N/A	N/A	DWS Offset (in)	N/A
N/A	Shared Landing?	N/A			
N/A	Gutter Ponding?	N/A	N/A	Gutter Slope (%)	N/A
N/A	Gutter Lip Ht (in)	N/A	N/A	Gutter X Slope (%)	N/A
N/A	Painted X Walk1?	No	N/A	Painted X Walk2?	N/A
	X Walk 1 Direction	To W		X Walk 2 Direction	N/A
N/A	X Walk 1 Width (in)	N/A	N/A	X Walk 2 Width (in)	N/A
	X Walk 1 Slope (%)	5.1		X Walk 2 Slope (%)	N/A
	X Walk 1 X Slope (%)	8.3		X Walk 2 X Slope (%)	N/A

N/A	Ramp inside XWalk1?	N/A	N/A	Ramp inside XWalk2?	N/A
	Road Slope (%)	N/A	N/A	Clear Space?	N/A
	Road X Slope (%)	N/A	N/A	Clear Space to XWalk (in)	N/A
N/A	Any Obstructions?	N/A	N/A	Storm Grate/Utility Hazard?	N/A
	Obstruction Type			Storm Grate/Utility Type	
		N/A			N/A
			Yes	Surface Condition? (G/P)	Good

Possible Solutions:

Remove & Replace Entire Ramp.
