# Access Compliance Report

## Public Rights-of-Way

### (Curb Ramps)

Intersection ID: 11615	Main Street: E_18TH_ST	Cross Street: N_ALEXANDER_ST	Location: NE
ADA ID: A48030D7A89A	Ramp Type: Perp	Initial Pass/Fail: Fail	Overall Compliance: No
Severity Score: 67.5			
Codes/Mitigation Info/Possible Solution		Field Measurements/Component Compliance

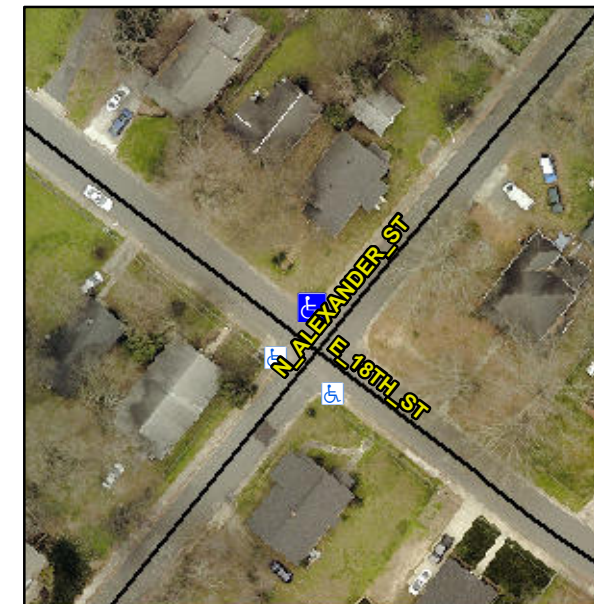
**Not Found, R304.5.1, R304.2.2, R304.5.3**

Compliance	Description	Data	Compliance	Description	Data
N/A	Ramp Length (in)	56.0	No	Ramp Slope (%)	14.8
No	Ramp Width (in)	35.0	No	Ramp XSlope (%)	11.6
N/A	Flare Type LT	N/A	N/A	Flare Type RT	N/A
N/A	Flare Slope LT (%)	N/A	N/A	Flare Slope RT (%)	N/A
N/A	Flare Traversable LT?	N/A	N/A	Flare Traversable RT?	N/A
N/A	Landing Length (in)	N/A	N/A	DWS Provided?	N/A
N/A	Landing Width (in)	N/A	N/A	DWS Contrast?	N/A
N/A	Landing Slope (%)	N/A	N/A	DWS Length (in)	N/A
N/A	Landing X Slope (%)	N/A	N/A	DWS Full Width?	N/A
N/A	Landing Curb? (Y/N)	N/A	N/A	DWS Offset (in)	N/A
N/A	Shared Landing?	N/A			
N/A	Gutter Ponding?	N/A	N/A	Gutter Slope (%)	N/A
N/A	Gutter Lip Ht (in)	0.5	N/A	Gutter X Slope (%)	N/A
N/A	Painted X Walk1?	No	N/A	Painted X Walk2?	N/A
	X Walk 1 Direction	To SW		X Walk 2 Direction	N/A
N/A	X Walk 1 Width (in)	N/A	N/A	X Walk 2 Width (in)	N/A
	X Walk 1 Slope (%)	0.4		X Walk 2 Slope (%)	N/A
	X Walk 1 X Slope (%)	2.9		X Walk 2 X Slope (%)	N/A

N/A	Ramp inside XWalk1?	N/A	N/A	Ramp inside XWalk2?	N/A
	Road Slope (%)	N/A	N/A	Clear Space?	N/A
	Road X Slope (%)	N/A	N/A	Clear Space to XWalk (in)	N/A
N/A	Any Obstructions?	N/A	N/A	Storm Grate/Utility Hazard?	N/A
	Obstruction Type			Storm Grate/Utility Type	
		N/A			N/A
			Yes	Surface Condition? (G/P)	Good

Possible Solutions:

**Remove & Replace Entire Ramp.**
