Access Compliance Report

Public Rights-of-Way

(Curb Ramps)

Intersection ID: 27397	Main Street: ELM_LN	Cross Street: BALLANTYNE_COMMONS_PY	Location: NE
ADA ID: A48684D779C2	Ramp Type: Perp	Initial Pass/Fail: Fail	Overall Compliance: No
Severity Score: 22.5			
Codes/Mitigation Info/Possible Solution		Field Measurements/Component Compliance

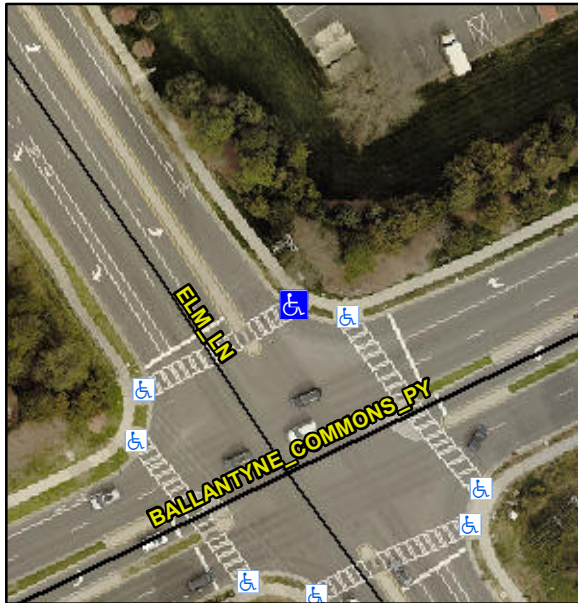
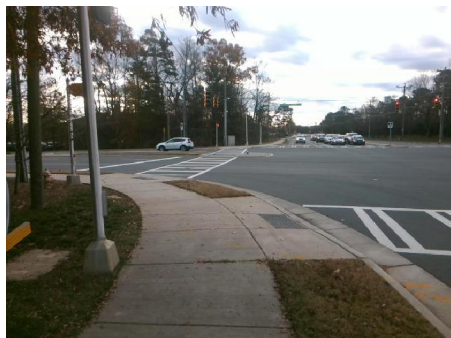
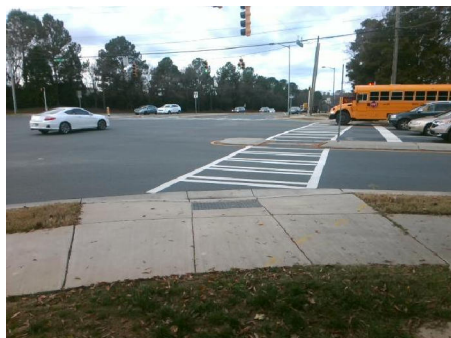
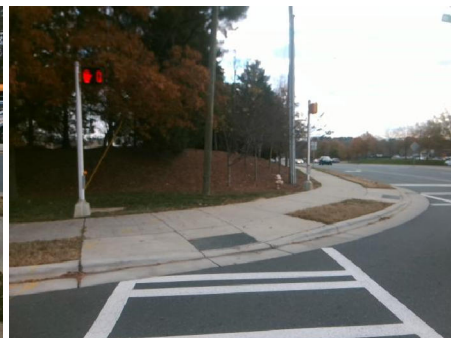
R304.5.1, R304.2.2, R304.5.3

Compliance	Description	Data	Compliance	Description	Data
N/A	Ramp Length (in)	47.0	No	Ramp Slope (%)	9.4
No	Ramp Width (in)	47.5	No	Ramp XSlope (%)	2.5
N/A	Flare Type LT	N/A	N/A	Flare Type RT	N/A
N/A	Flare Slope LT (%)	N/A	N/A	Flare Slope RT (%)	N/A
N/A	Flare Traversable LT?	N/A	N/A	Flare Traversable RT?	N/A
N/A	Landing Length (in)	N/A	N/A	DWS Provided?	N/A
N/A	Landing Width (in)	N/A	N/A	DWS Contrast?	N/A
N/A	Landing Slope (%)	N/A	N/A	DWS Length (in)	N/A
N/A	Landing X Slope (%)	N/A	N/A	DWS Full Width?	N/A
N/A	Landing Curb? (Y/N)	N/A	N/A	DWS Offset (in)	N/A
N/A	Shared Landing?	N/A			
N/A	Gutter Ponding?	N/A	N/A	Gutter Slope (%)	N/A
N/A	Gutter Lip Ht (in)	N/A	N/A	Gutter X Slope (%)	N/A
N/A	Painted X Walk1?	Yes	N/A	Painted X Walk2?	N/A
	X Walk 1 Direction	To SW		X Walk 2 Direction	N/A
N/A	X Walk 1 Width (in)	113.0	N/A	X Walk 2 Width (in)	N/A
	X Walk 1 Slope (%)	0.8		X Walk 2 Slope (%)	N/A
	X Walk 1 X Slope (%)	0.6		X Walk 2 X Slope (%)	N/A

N/A	Ramp inside XWalk1?	Yes	N/A	Ramp inside XWalk2?	N/A
	Road Slope (%)	N/A	N/A	Clear Space?	N/A
	Road X Slope (%)	N/A	N/A	Clear Space to XWalk (in)	N/A
N/A	Any Obstructions?	N/A	N/A	Storm Grate/Utility Hazard?	N/A
	Obstruction Type			Storm Grate/Utility Type	
		N/A			N/A
		Yes		Surface Condition? (G/P)	Good

Remove & Replace Entire Ramp.
