# Access Compliance Report

## Public Rights-of-Way

### (Curb Ramps)

Intersection ID: 3159	Main Street: DAUPHINE_DR	Cross Street: MAGENNIS_GROVE_CT	Location: S
ADA ID: A4A0C85DD47D	Ramp Type: Perp	Initial Pass/Fail: Fail	Overall Compliance: No
Severity Score: 37.5			
Codes/Mitigation Info/Possible Solution		Field Measurements/Component Compliance

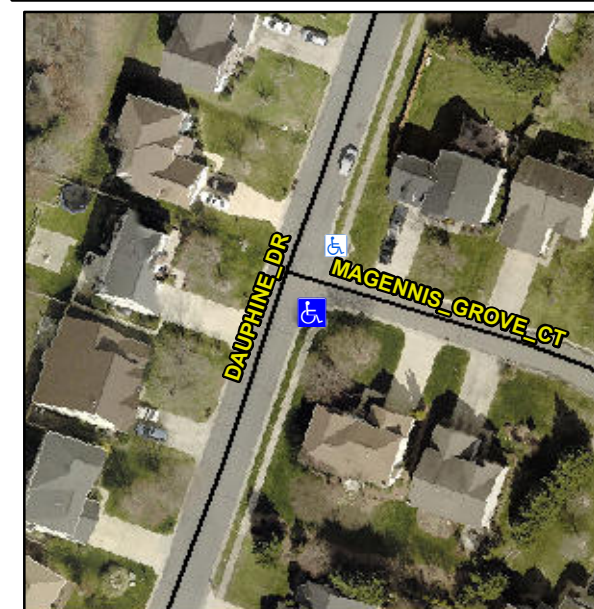
Compliance	Description	Data	Compliance	Description	Data
N/A	Ramp Length (in)	51.0	No	Ramp Slope (%)	9.5
Yes	Ramp Width (in)	48.0	No	Ramp XSlope (%)	8.7
N/A	Flare Type LT	N/A	N/A	Flare Type RT	N/A
N/A	Flare Slope LT (%)	N/A	N/A	Flare Slope RT (%)	N/A
N/A	Flare Traversable LT?	N/A	N/A	Flare Traversable RT?	N/A
N/A	Landing Length (in)	N/A	N/A	DWS Provided?	N/A
N/A	Landing Width (in)	N/A	N/A	DWS Contrast?	N/A
N/A	Landing Slope (%)	N/A	N/A	DWS Length (in)	N/A
N/A	Landing X Slope (%)	N/A	N/A	DWS Full Width?	N/A
N/A	Landing Curb? (Y/N)	N/A	N/A	DWS Offset (in)	N/A
N/A	Shared Landing?	N/A			
N/A	Gutter Ponding?	N/A	N/A	Gutter Slope (%)	N/A
N/A	Gutter Lip Ht (in)	N/A	N/A	Gutter X Slope (%)	N/A
N/A	Painted X Walk1?	No	N/A	Painted X Walk2?	N/A
	X Walk 1 Direction	To NE		X Walk 2 Direction	N/A
N/A	X Walk 1 Width (in)	N/A	N/A	X Walk 2 Width (in)	N/A
	X Walk 1 Slope (%)	4.4		X Walk 2 Slope (%)	N/A
	X Walk 1 X Slope (%)	7.1		X Walk 2 X Slope (%)	N/A

N/A	Ramp inside XWalk1?	N/A	N/A	Ramp inside XWalk2?	N/A
	Road Slope (%)	N/A	N/A	Clear Space?	N/A
	Road X Slope (%)	N/A	N/A	Clear Space to XWalk (in)	N/A
N/A	Any Obstructions?	N/A	N/A	Storm Grate/Utility Hazard?	N/A
	Obstruction Type			Storm Grate/Utility Type	
		N/A			N/A
			Yes	Surface Condition? (G/P)	Good

Possible Solutions:

**Remove & Replace Entire Ramp.**

**R304.2.2, R304.5.3**

Total Cost: \$ 1850.00
