# Access Compliance Report

## Public Rights-of-Way

### (Curb Ramps)

Intersection ID: 43663	Main Street: TAYLOR RIDGE LN	Cross Street: HUNTINGTON MEADOW LN	Location: NE
ADA ID: A4A149FC5205	Ramp Type: Combination1Diag	Initial Pass/Fail: Fail	Overall Compliance: No
		Severity Score: 0

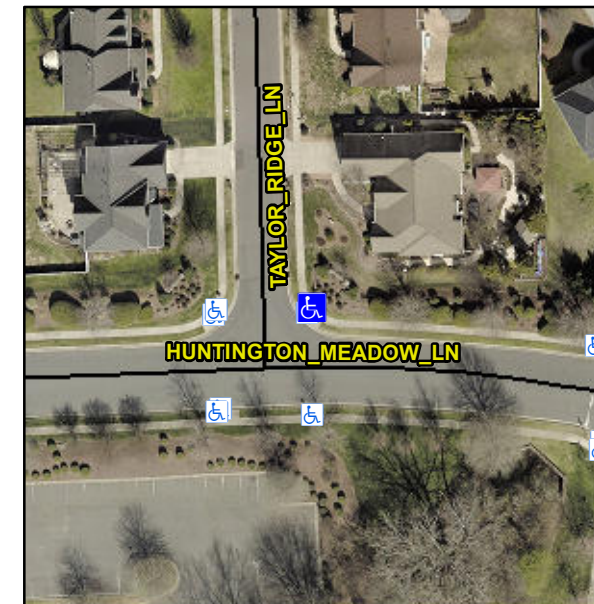
**LT RP < 5%**

**R304.5.1, R304.5.1, R304.2.2, R304.5.3**

Compliance	Description	Data	Compliance	Description	Data
N/A	Ramp Length LT (in)	53.0	N/A	Ramp Length RT (in)	54.0
Yes	Ramp Width LT (in)	48.0	No	Ramp Width RT (in)	47.0
Yes	Ramp Slope LT (%)	1.4	Yes	Ramp Slope RT (%)	5.9
No	Ramp XSlope LT (%)	4.4	No	Ramp XSlope RT (%)	4.5
N/A	Ramp Length (in)	75.0	No	Ramp Slope (%)	9.1
No	Ramp Width (in)	33.0	No	Ramp XSlope (%)	5.1
N/A	Flare Type LT	N/A	N/A	Flare Type RT	N/A
N/A	Flare Slope LT (%)	N/A	N/A	Flare Slope RT (%)	N/A
N/A	Flare Traversable LT?	N/A	N/A	Flare Traversable RT?	N/A
N/A	Landing Length (in)	N/A	N/A	DWS Provided?	N/A
N/A	Landing Width (in)	N/A	N/A	DWS Contrast?	N/A
N/A	Landing Slope (%)	N/A	N/A	DWS Length (in)	N/A
N/A	Landing X Slope (%)	N/A	N/A	DWS Full Width?	N/A
N/A	Landing Curb? (Y/N)	N/A	N/A	DWS Offset (in)	N/A
N/A	Shared Landing?	N/A			
N/A	Gutter Ponding?	N/A	N/A	Gutter Slope (%)	N/A
N/A	Gutter Lip Ht (in)	N/A	N/A	Gutter X Slope (%)	N/A
N/A	Painted X Walk1?	No	N/A	Painted X Walk2?	No

X Walk 1 Direction	To W		X Walk 2 Direction	To S
	X Walk 1 Width (in)	N/A		X Walk 2 Width (in)	N/A
	X Walk 1 Slope (%)	0.5		X Walk 2 Slope (%)	1.2
	X Walk 1 X Slope (%)	0.5		X Walk 2 X Slope (%)	2.2
N/A	Ramp inside XWalk1?	N/A	N/A	Ramp inside XWalk2?	N/A
	Road Slope (%)	1.9		Clear Space?	N/A
	Road X Slope (%)	2.4	N/A	Clear Space to XWalk (in)	N/A
			N/A	Any Obstruction?	N/A
				Obstruction Type	N/A
			N/A	Storm Grate/Utility Hazard?	N/A
				Storm Grate/Utility Type	N/A
			Yes	Surface Condition? (G/P)	Good
				Curb Slope (%)	2.9

**Remove & Replace Curb Ramp With Two New Directional Ramps or Equivalent.**

**\$ 3200.00**
