# Access Compliance Report

## Public Rights-of-Way

### (Curb Ramps)

Intersection ID: 10023487	Main Street: CIRCUMFERENTIAL_RD	Cross Street: N/A	Location: E
ADA ID: A4A58EF4E87A	Ramp Type: Perp	Initial Pass/Fail: Fail	Overall Compliance: No
Severity Score: 21.25			
Codes/Mitigation Info/Possible Solution		Field Measurements/Component Compliance

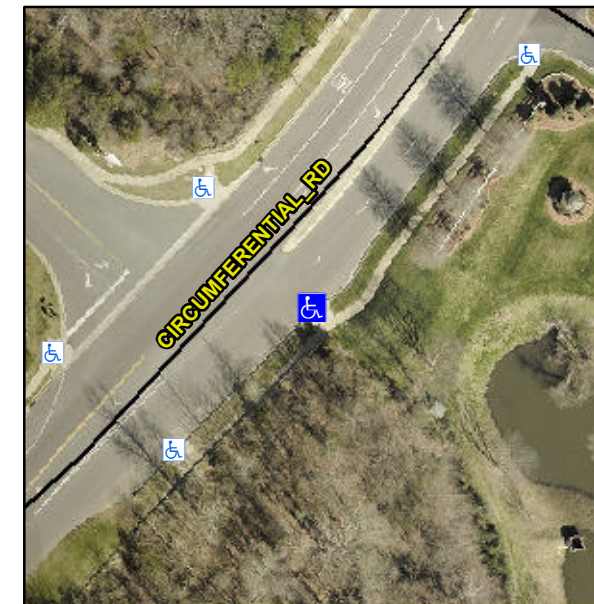
**Not Found, R304.5.1, R304.5.3**

Compliance	Description	Data	Compliance	Description	Data
N/A	Ramp Length (in)	102.0	Yes	Ramp Slope (%)	6.4
No	Ramp Width (in)	47.5	No	Ramp XSlope (%)	5.6
N/A	Flare Type LT	N/A	N/A	Flare Type RT	N/A
N/A	Flare Slope LT (%)	N/A	N/A	Flare Slope RT (%)	N/A
N/A	Flare Traversable LT?	N/A	N/A	Flare Traversable RT?	N/A
N/A	Landing Length (in)	N/A	N/A	DWS Provided?	N/A
N/A	Landing Width (in)	N/A	N/A	DWS Contrast?	N/A
N/A	Landing Slope (%)	N/A	N/A	DWS Length (in)	N/A
N/A	Landing X Slope (%)	N/A	N/A	DWS Full Width?	N/A
N/A	Landing Curb? (Y/N)	N/A	N/A	DWS Offset (in)	N/A
N/A	Shared Landing?	N/A			
N/A	Gutter Ponding?	N/A	N/A	Gutter Slope (%)	N/A
N/A	Gutter Lip Ht (in)	N/A	N/A	Gutter X Slope (%)	N/A
N/A	Painted X Walk1?	No	N/A	Painted X Walk2?	N/A
	X Walk 1 Direction	To NW		X Walk 2 Direction	N/A
N/A	X Walk 1 Width (in)	N/A	N/A	X Walk 2 Width (in)	N/A
	X Walk 1 Slope (%)	0.4		X Walk 2 Slope (%)	N/A
	X Walk 1 X Slope (%)	2.5		X Walk 2 X Slope (%)	N/A

N/A	Ramp inside XWalk1?	N/A	N/A	Ramp inside XWalk2?	N/A
	Road Slope (%)	N/A	N/A	Clear Space?	N/A
	Road X Slope (%)	N/A	N/A	Clear Space to XWalk (in)	N/A
N/A	Any Obstructions?	N/A	N/A	Storm Grate/Utility Hazard?	N/A
	Obstruction Type			Storm Grate/Utility Type	
		N/A			N/A
			Yes	Surface Condition? (G/P)	Good

**Remove & Replace Entire Ramp.**

Total Cost: \$ 1850.00
